# Annual Monitoring Review and Management Report 2025–2026

**MMG Rosebery**

Date: 30/09/2026

Prepared by MMG Rosebery

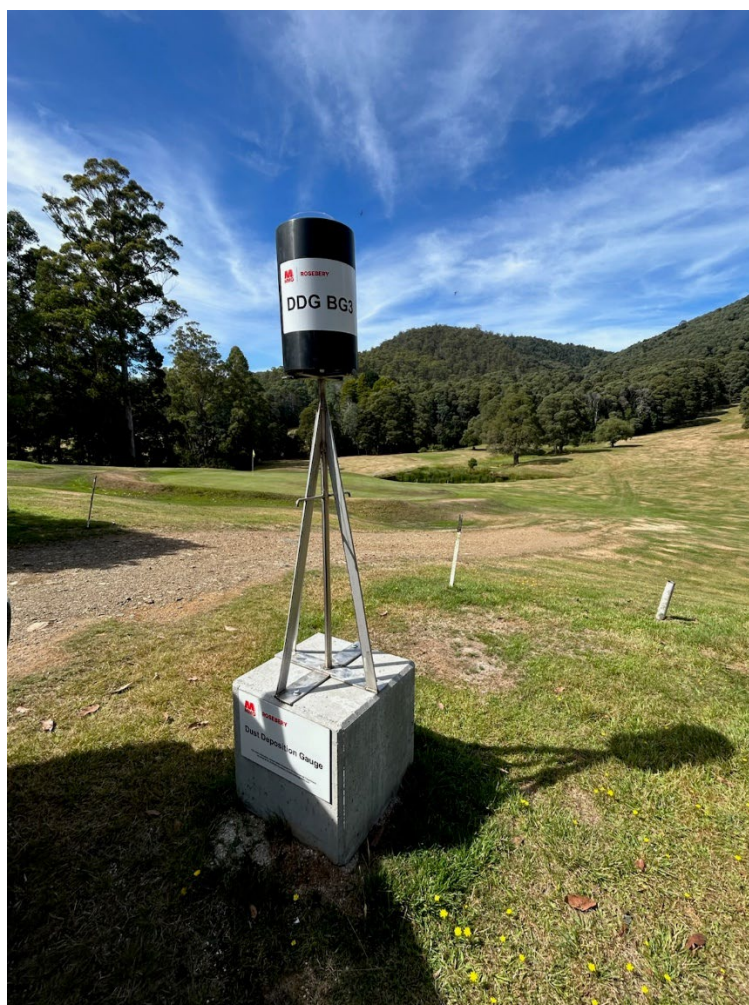
Figure 2. One of the upgraded dust deposition gauges installed across the Air Quality Monitoring Network.

| Commitment | Details | Current Status |
|---|---|---|
| Dust deposition network upgrade | Following audit recommendations, MMG Rosebery has committed to upgrade the dust deposition network. | Approval received from EPA to upgrade existing infrastructure and relocate some of the dust deposition gauges in July 2025. New infrastructure has been installed and is now part of the monitoring program. |

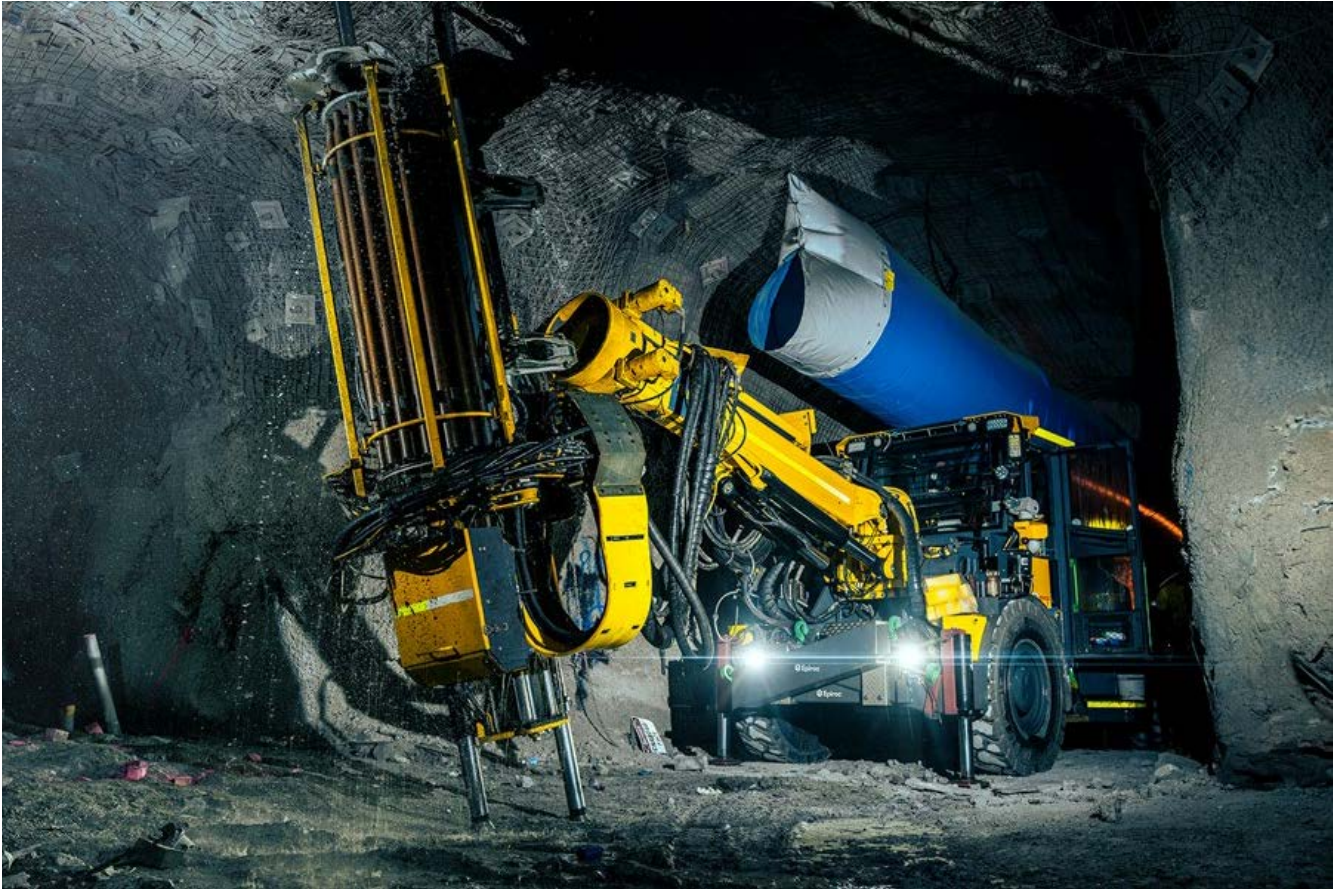
Figure 4. MMG Rosebery's Epiroc Simba E70SG replaced diesel with battery power.

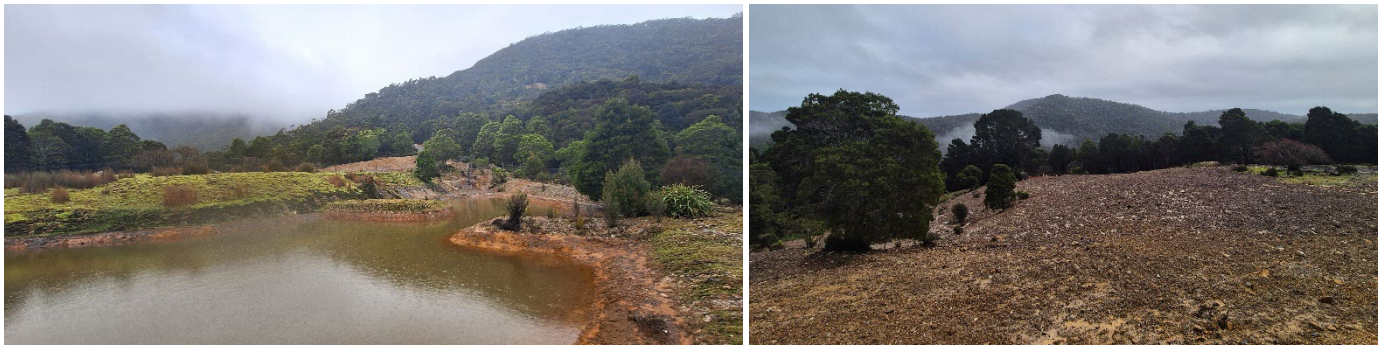
Figure 6. WSP before (left) and after (right) civil works have been completed in June 2026.

Decommissioning of the WSP commenced on 29 April 2026 and concluded 19 June 2026. Over 25 working days, approximately 0.17 ha was rehabilitated. Impacted sediment was progressively removed and transported to the Bobadil TSF. Following sediment removal, the ponds were treated with crushed limestone and backfilled. Disturbed surfaces were then re-spread with stockpiled topsoil, and the final surface was cultivated along the contour to form a loose, friable growing medium. Native seed from species and provenance suitable for the Williamsford area was applied at approximately 6 kg/ha across all disturbed areas and then fertilised at a rate of 300 kg/ha. Standard site safety and *Phytophthora* hygiene controls were maintained throughout, with no safety, environmental or community incidents recorded. Future works include ongoing monitoring via drone imagery.

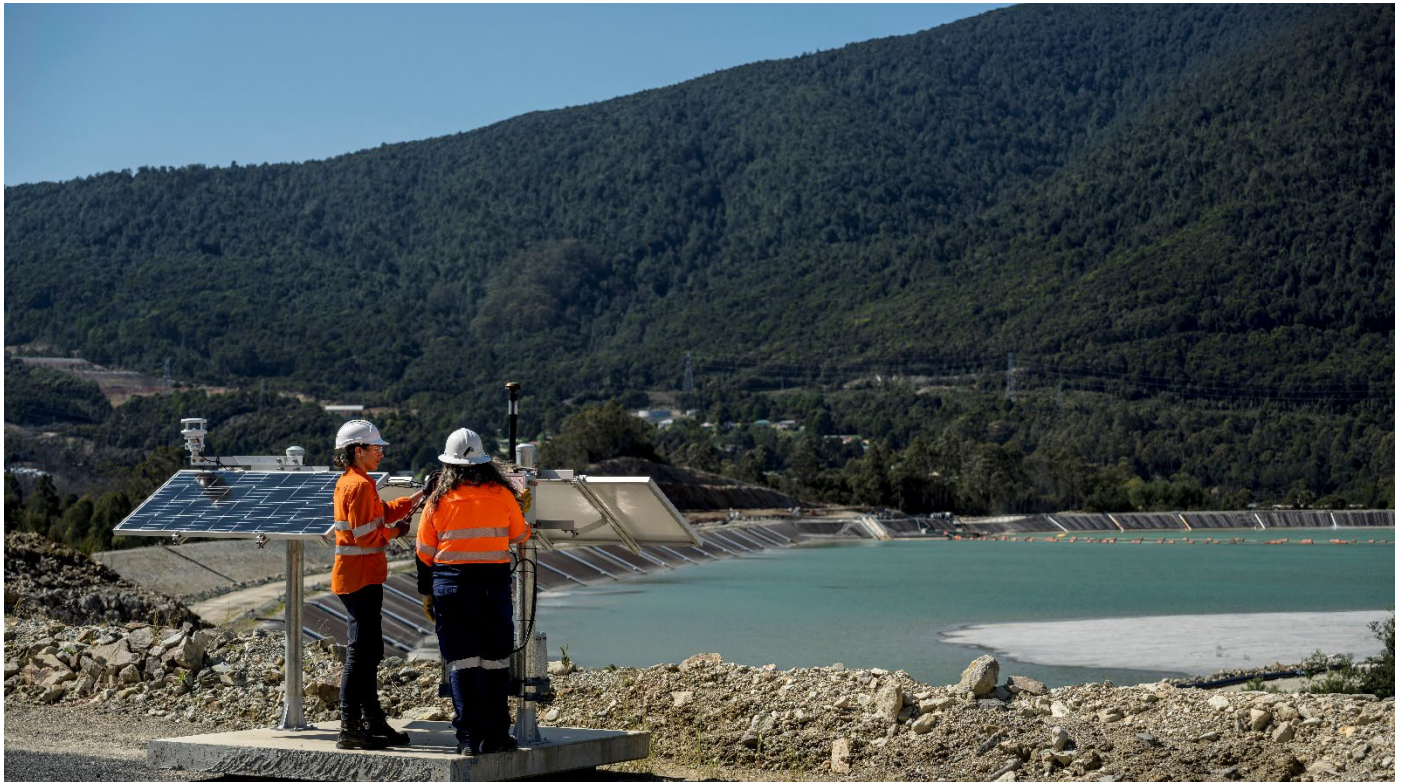
Figure 9. Real-time air quality monitors installed around the 2/5 Dam TSF.

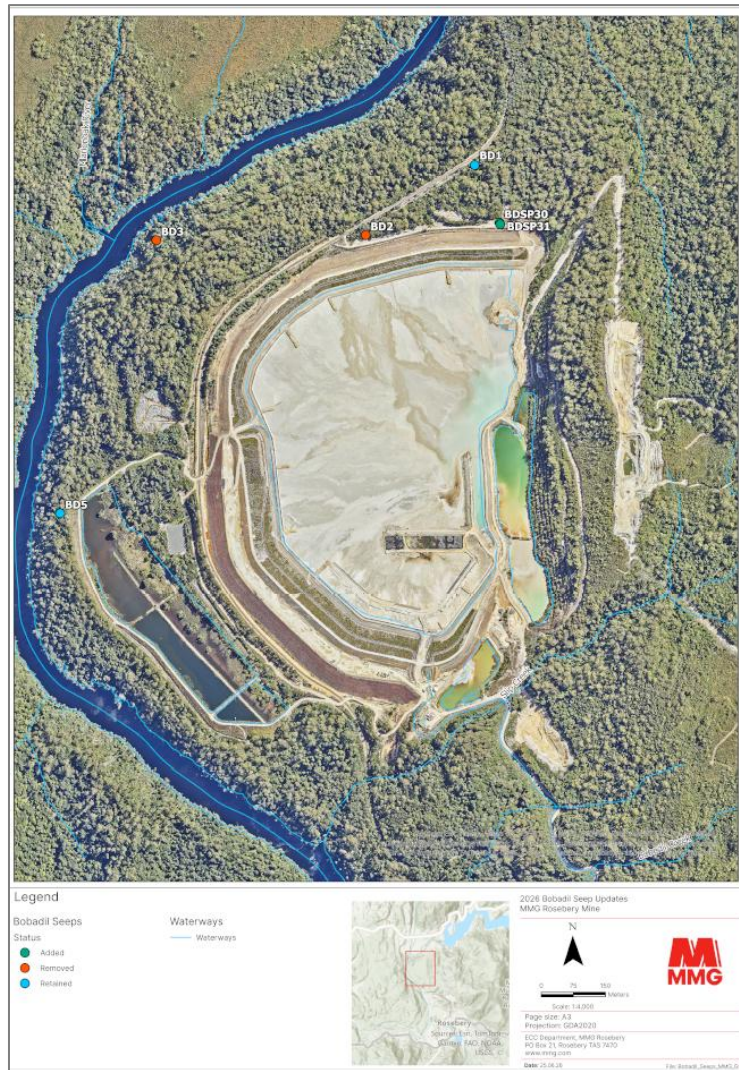
Figure 5-1. Seepage monitoring locations at Bobadil TSF showing retained, new and removed sites.

The EPA approved a request by MMG Rosebery to alter the monitoring requirements for the Bobadil seeps to focus on active seeps that enter the environment. The changes were necessary because since 2011, when the original seepage monitoring requirements were established in the EPN, the expansion of Bobadil and other water management changes have altered seepage flow from the TSF. The historic and newly approved seepage monitoring sites are shown in Figure 5-1 and Table 4 along with the monitoring quarter in which they were required to be monitored based on the revised plan. The parameters included in the monitoring have also been revised, with the new requirements shown in Table 6. The revised parameters include WAD and Free CN and eliminate fluoride and chloride. Monitoring compliance for the first two quarters is evaluated against the original EPN criteria, with the last two quarters evaluated against the revised criteria. Flow monitoring infrastructure is required to be operational at BD1 by September 2026 so flow at this site is not included in the data review.

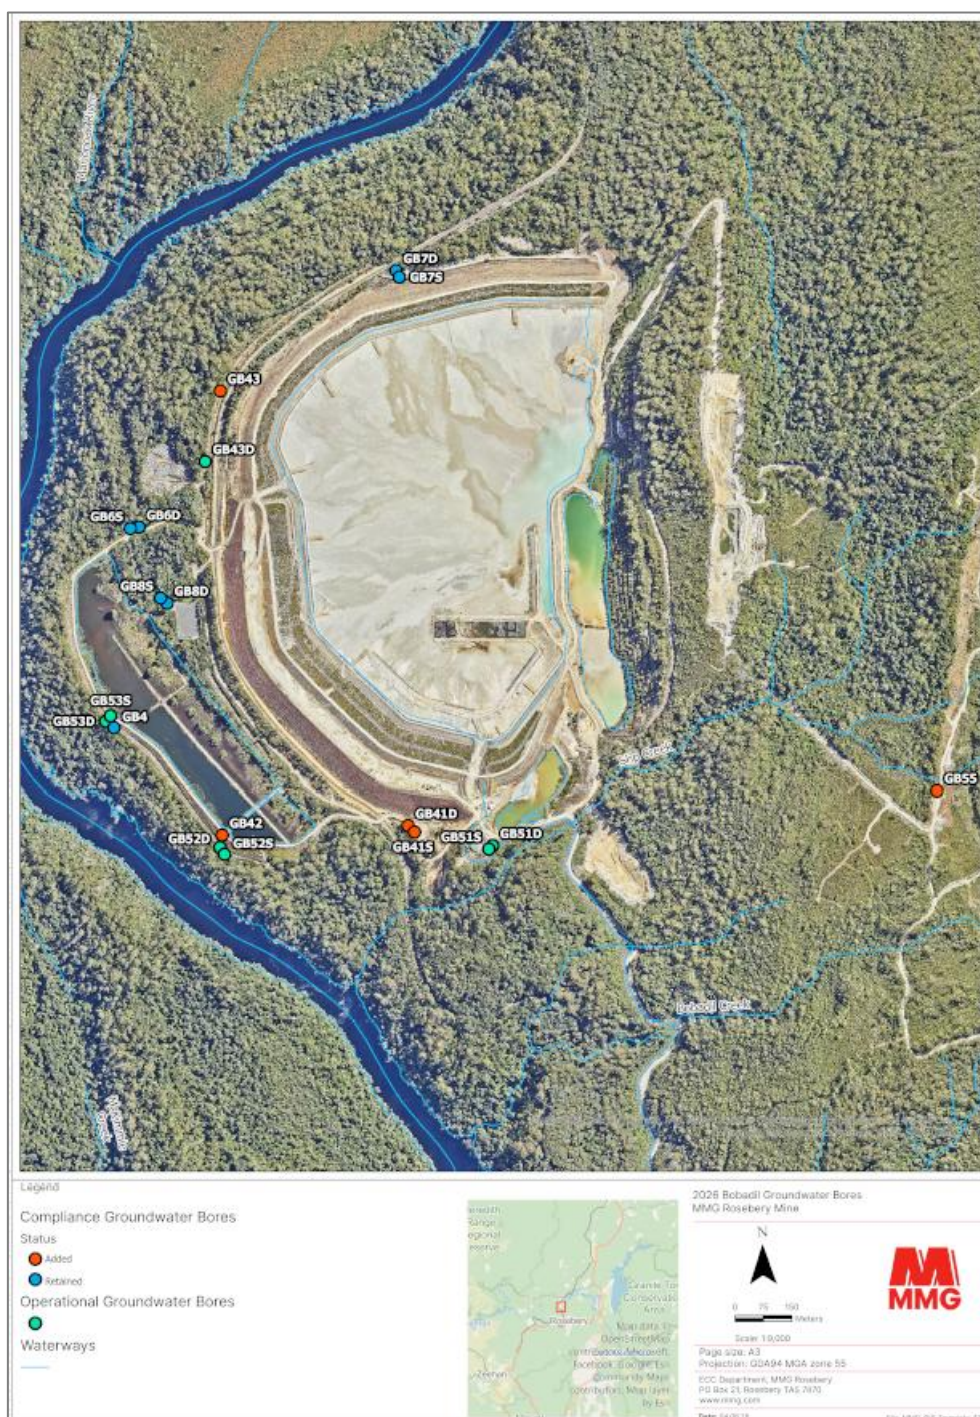
Figure 6-1. Location of groundwater monitoring bores near the Bobadil TSF.

monitoring round, although an extensive historical data set exists for most parameters at all sites. The locations of the compliance and operational bores are shown in Figure 6-1 with a summary of groundwater monitoring results is contained in Table 8.

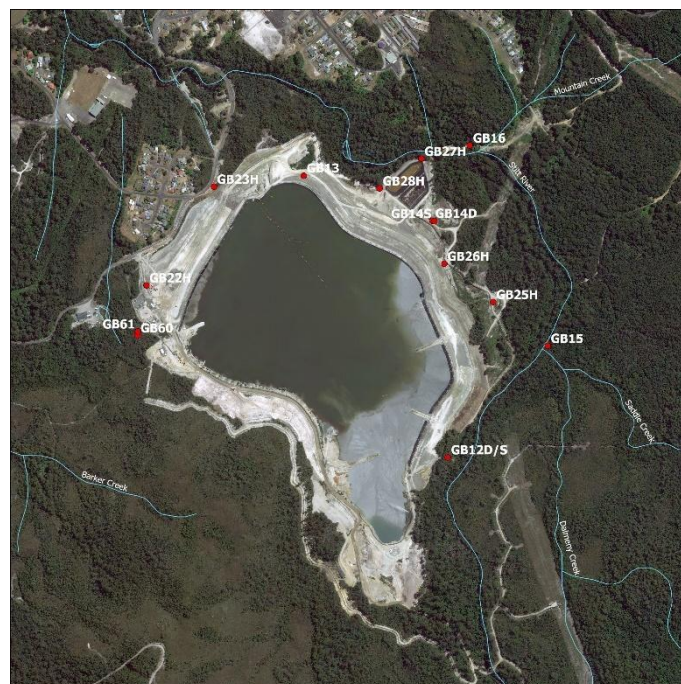
**Figure 7-2. Groundwater bore monitoring locations associated with the 2/5 Dam TSF.**

During the 2025 to 2026 monitoring year there was no discharge of decant water from the 2/5 Dam TSF to the Stitt River, nor spillage of seepage water from the Seepage Collection Pond (SCP) to the Stitt river. Compliance water quality monitoring is based on the sites listed in Table 9 and Figure 7-2. The 2/5 TSF results are reported in four parts. Section 7.1 describes the surface water and seepage results associated with the TSF, Section 7.2 describes the water quality in the Stitt River receiving environment, Section 7.3 summarises the groundwater monitoring results, and Section 7.4 presents the results of stormwater monitoring along the Murchison Highway.

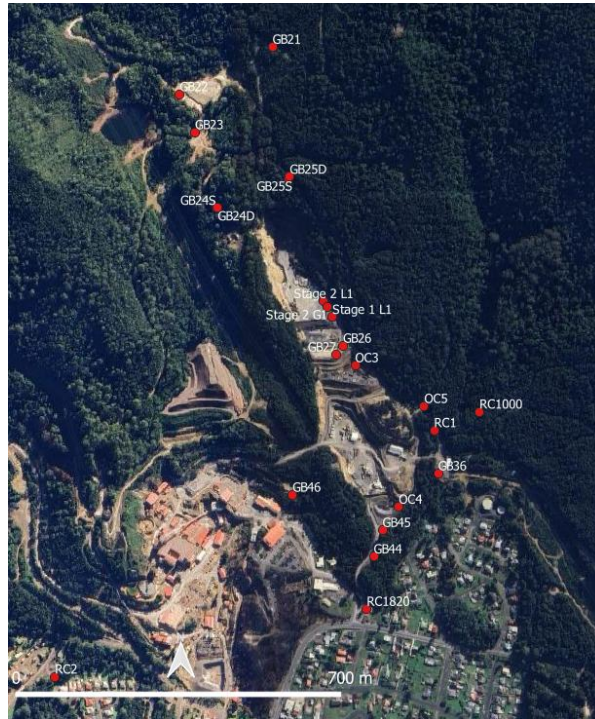
Figure 14-1. Surface water and groundwater monitoring locations associated with the 3 Level WRD.

Monitoring locations at the 3 Level WRD are shown in Figure 14-1 and a summary of the monitoring results is contained in Table 23.

| Compliance with EPN –<br>Assessment of groundwater impacts from the 3 Level WRD | <p>The EPN requires an assessment of groundwater impacts associated with 3 Level WRD. The relative position of the groundwater bores is shown in Figure 14-1.</p> <ul style="list-style-type: none"> <li>• Monitoring results were within the range of previous results except in bore GB46 where pH levels were higher and sulphate lower in April. Sulphate was also lower at GB36 and GB44. (Figure 14-8 to Figure 14-10)</li> <li>• Bores near the top of the valley (GB21-GB25) continue to have higher pH and lower zinc and sulphate concentrations as compared to bores located downslope of the WRD and open cut.</li> <li>• The bores at the base of the WRD (GB27, GB36, GB44, GB46) are characterised by low pH and elevated zinc and sulphate concentrations.</li> <li>• Bore GB23 continues to record elevated zinc (12-18 mg/L) and sulphate (97-140 mg/L) concentrations even though it is located well above the open cut and WRD. This bore is in the Northern Open Cut Area and is presumably impacted by the historic workings. This is consistent with the elevated concentrations of zinc and sulphate recorded at the stormwater runoff monitored at site AC1/AC1.1.</li> <li>• In GB27, which is located within the PAF material in the WRD and has consistently recorded the highest metal concentrations, the copper concentrations in both monitoring runs were substantially lower than previously recorded (Figure 14-11). The decrease in copper is not attributable to a change in pH as pH at the site remained &lt;3.5 during both monitoring runs. The concentrations of other metals have remained similar to historic results at the site. The cause for the decrease is unknown.</li> <li>• Water levels in the groundwater bores show seasonal trends, with water levels higher in (e.g., decrease in depth to water surface) in October/November, and lower in April, following the dry summer months. Water levels recorded in bore GB25S continue to show rapid change. Water level seasonal changes ranged from -4.5 m to +0.4 m at the sites (Figure 14-12, Figure 14-13) with the dry conditions leading to a reduction in water in many bores during both sampling runs.</li> </ul> |

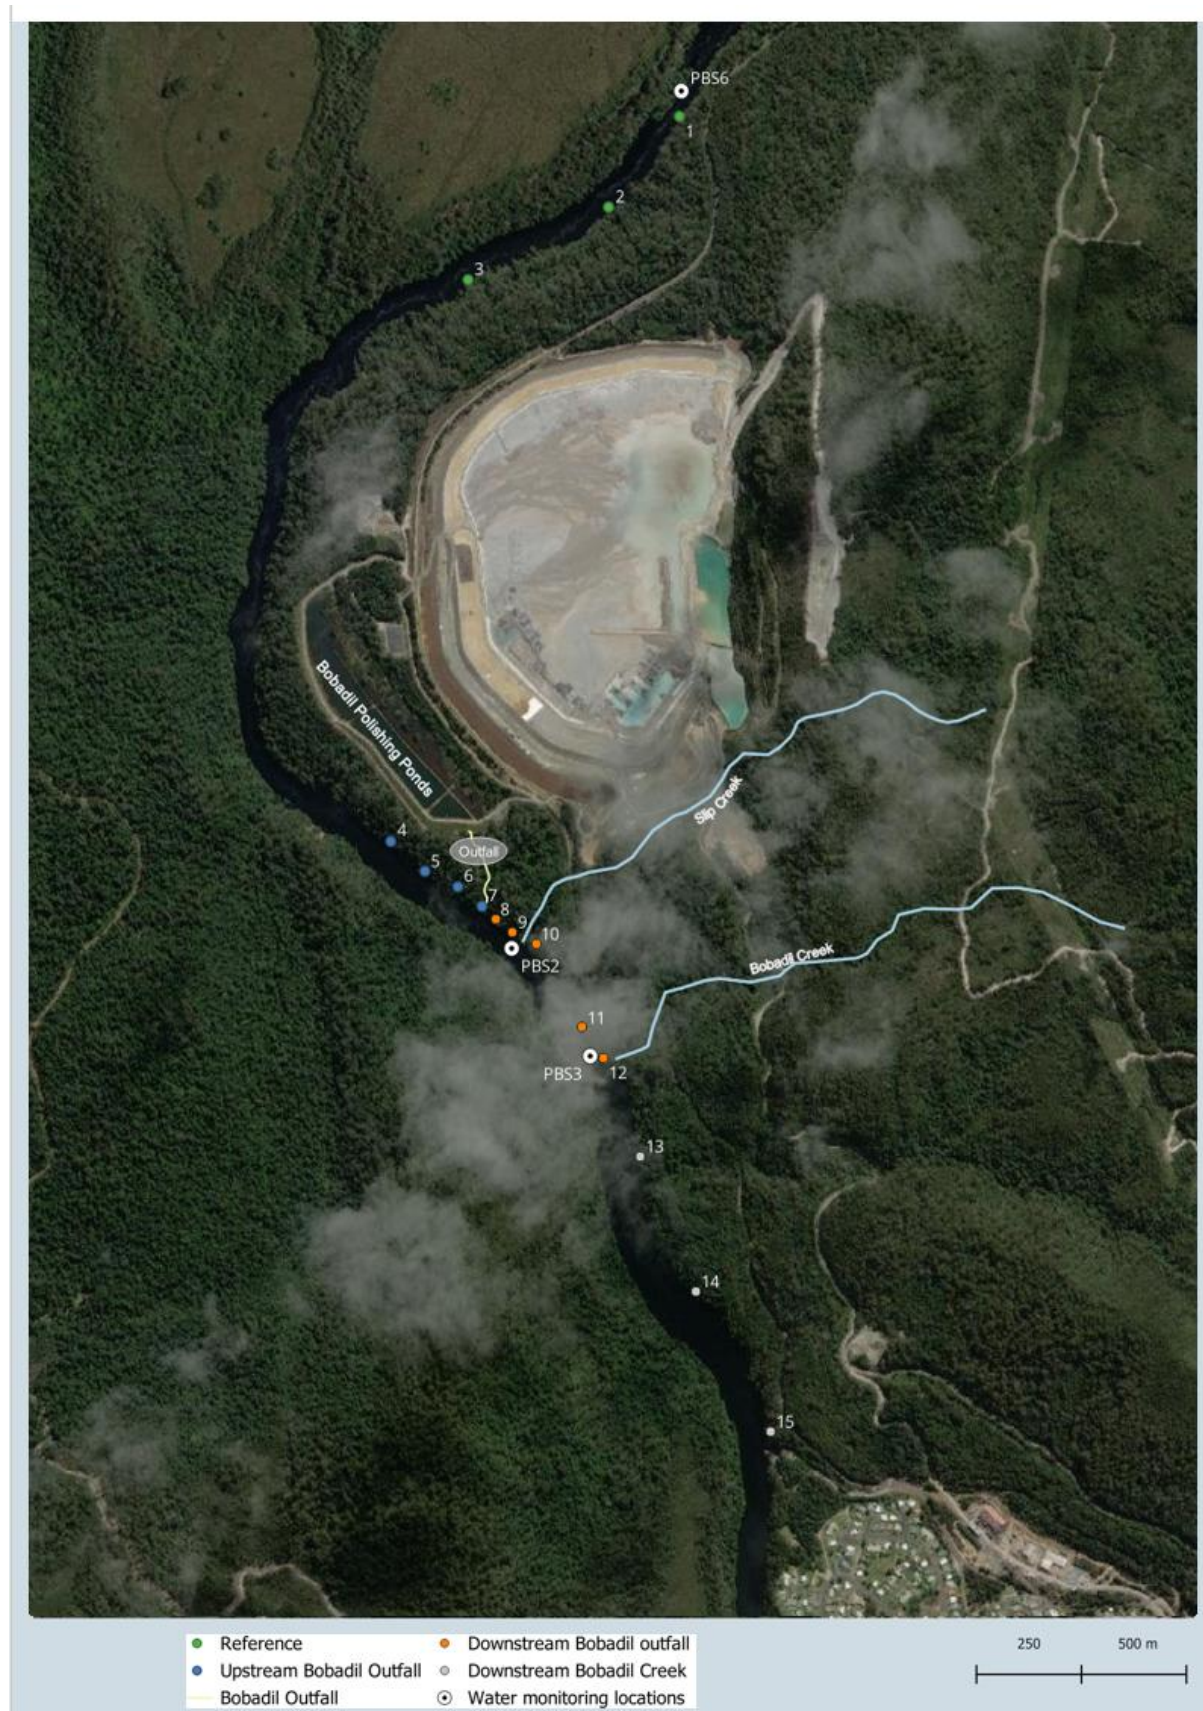
Figure 1.1: Distribution of biomonitoring sites for the Lake Pieman biomonitoring program. The long-term lake water quality sites are also shown

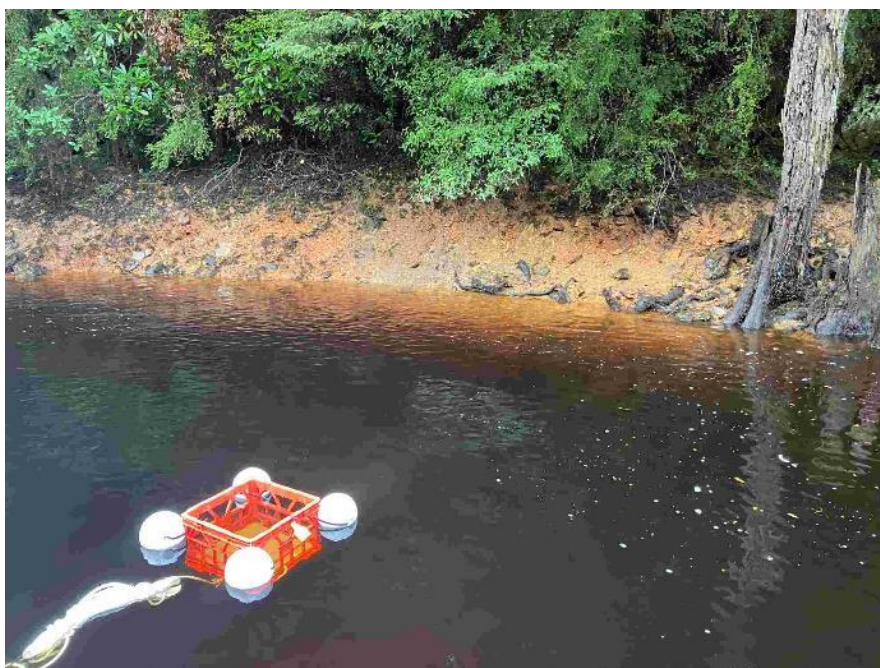
Figure 2.1: Example of the system deployed for sampling algae in Lake Pieman in 2024.

The same scrape method was also used to sample the suspended tile system in December 2025 (Figure 2.1).

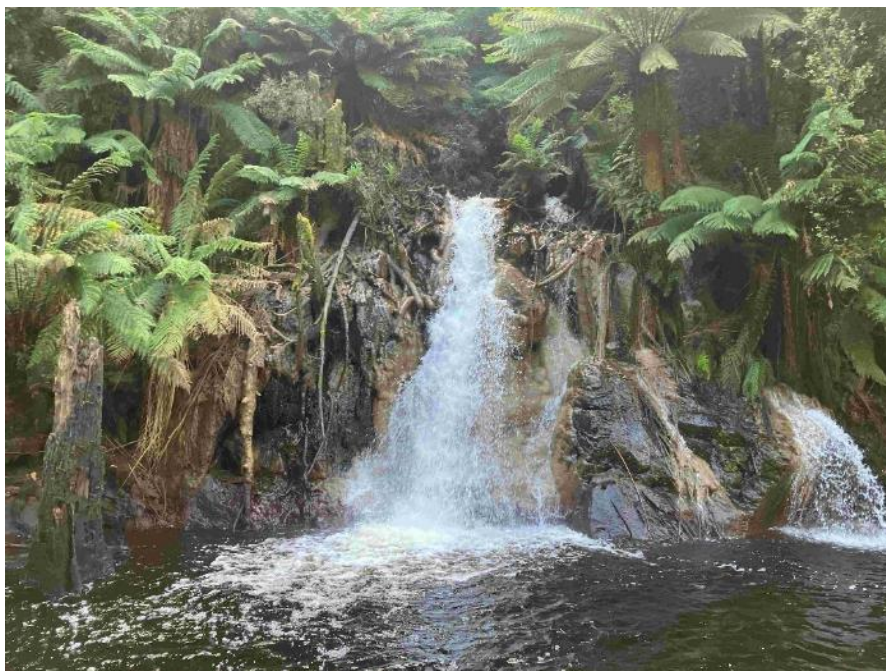
Figure 3.3: Bobadil discharge into Lake Pieman between sites 7 and 8.

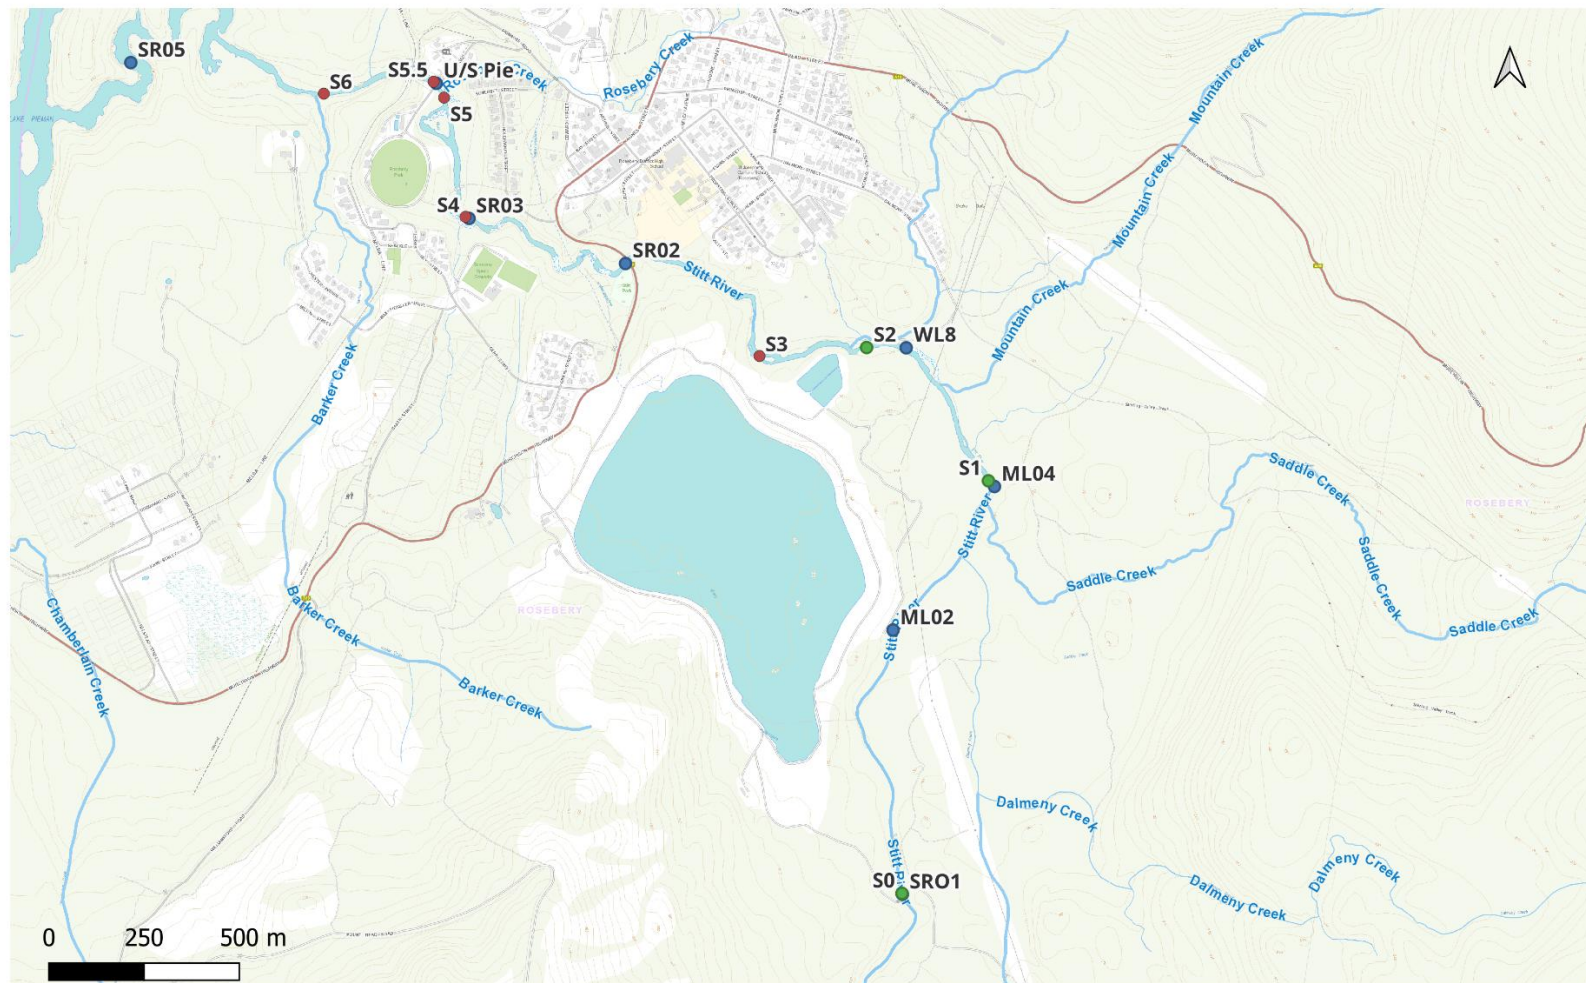
Figure 2.2: Location of biomonitoring and long-term water quality sites on the Stitt River

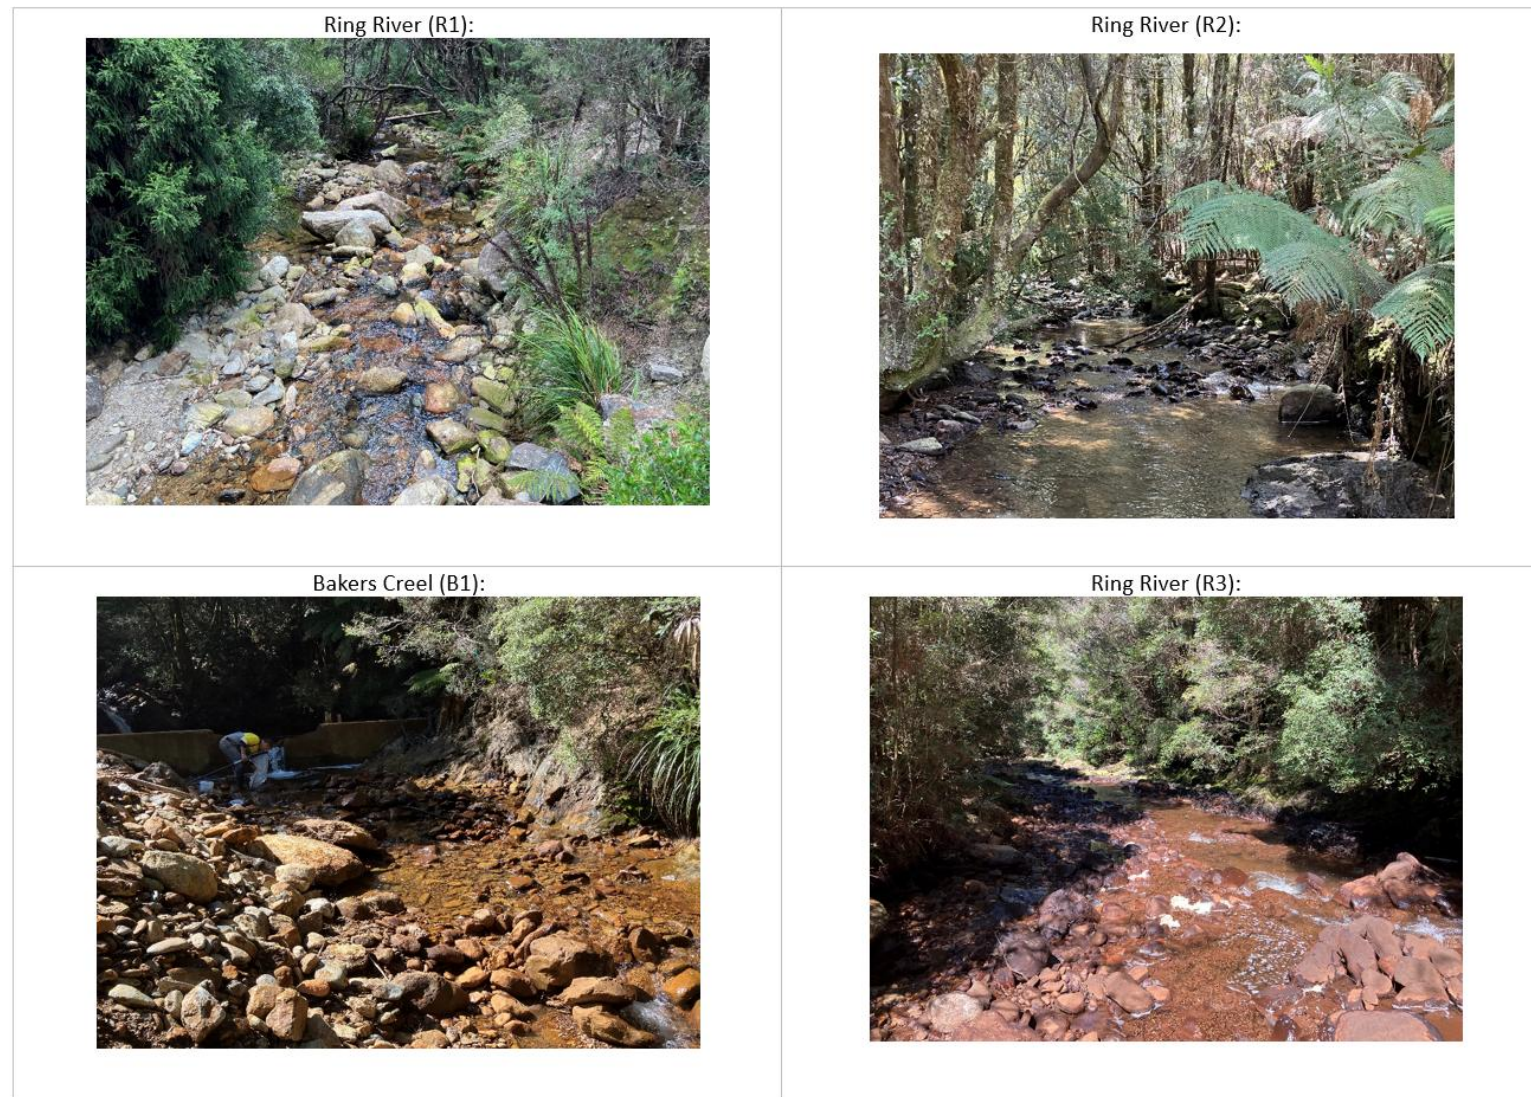
Figure 2.3: Ring River catchment sites R1, R2, B1 and R3

- Seven monitoring sites in the Ring River catchment which are impacted by historical mining operation and include five sites in the main river, one site in Baker Creek which enters between sites R2 and R3 and one site in Dolcoath Creek which enters between R5 and R6 (Table 2.1; Figure 2.1; Figure 2.3; Figure 2.4).
- Eight monitoring sites in the Stitt River catchment (Table 2.1; Figure 2.1; Figure 2.2):
  - Three reference sites in the Stitt River (Sites S0, S1, S2) (Figure 2.5);
  - Five impact sites in the Stitt River (Sites S3, S4, S5, S5.5 and S6) (Figure 2.6);
- One reference site in the Sterling River (Table 2.1; Figure 2.1; Figure 2.5).

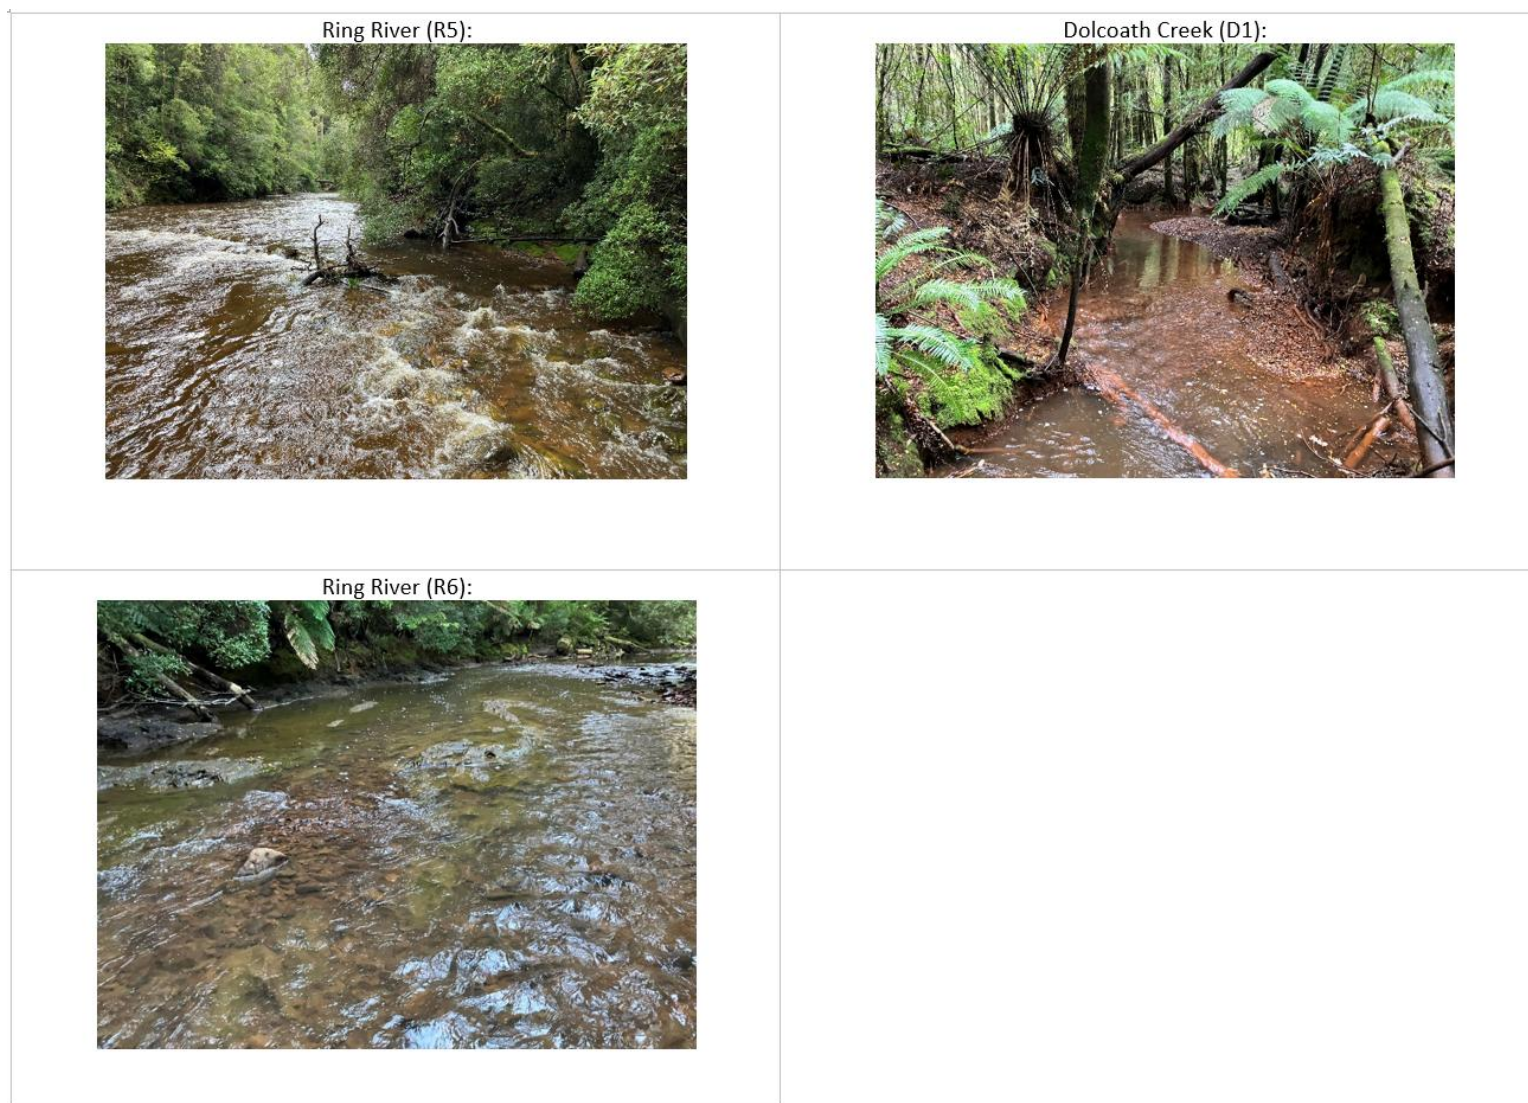
Figure 2.4: Ring River catchment sites R5, D1 and R6

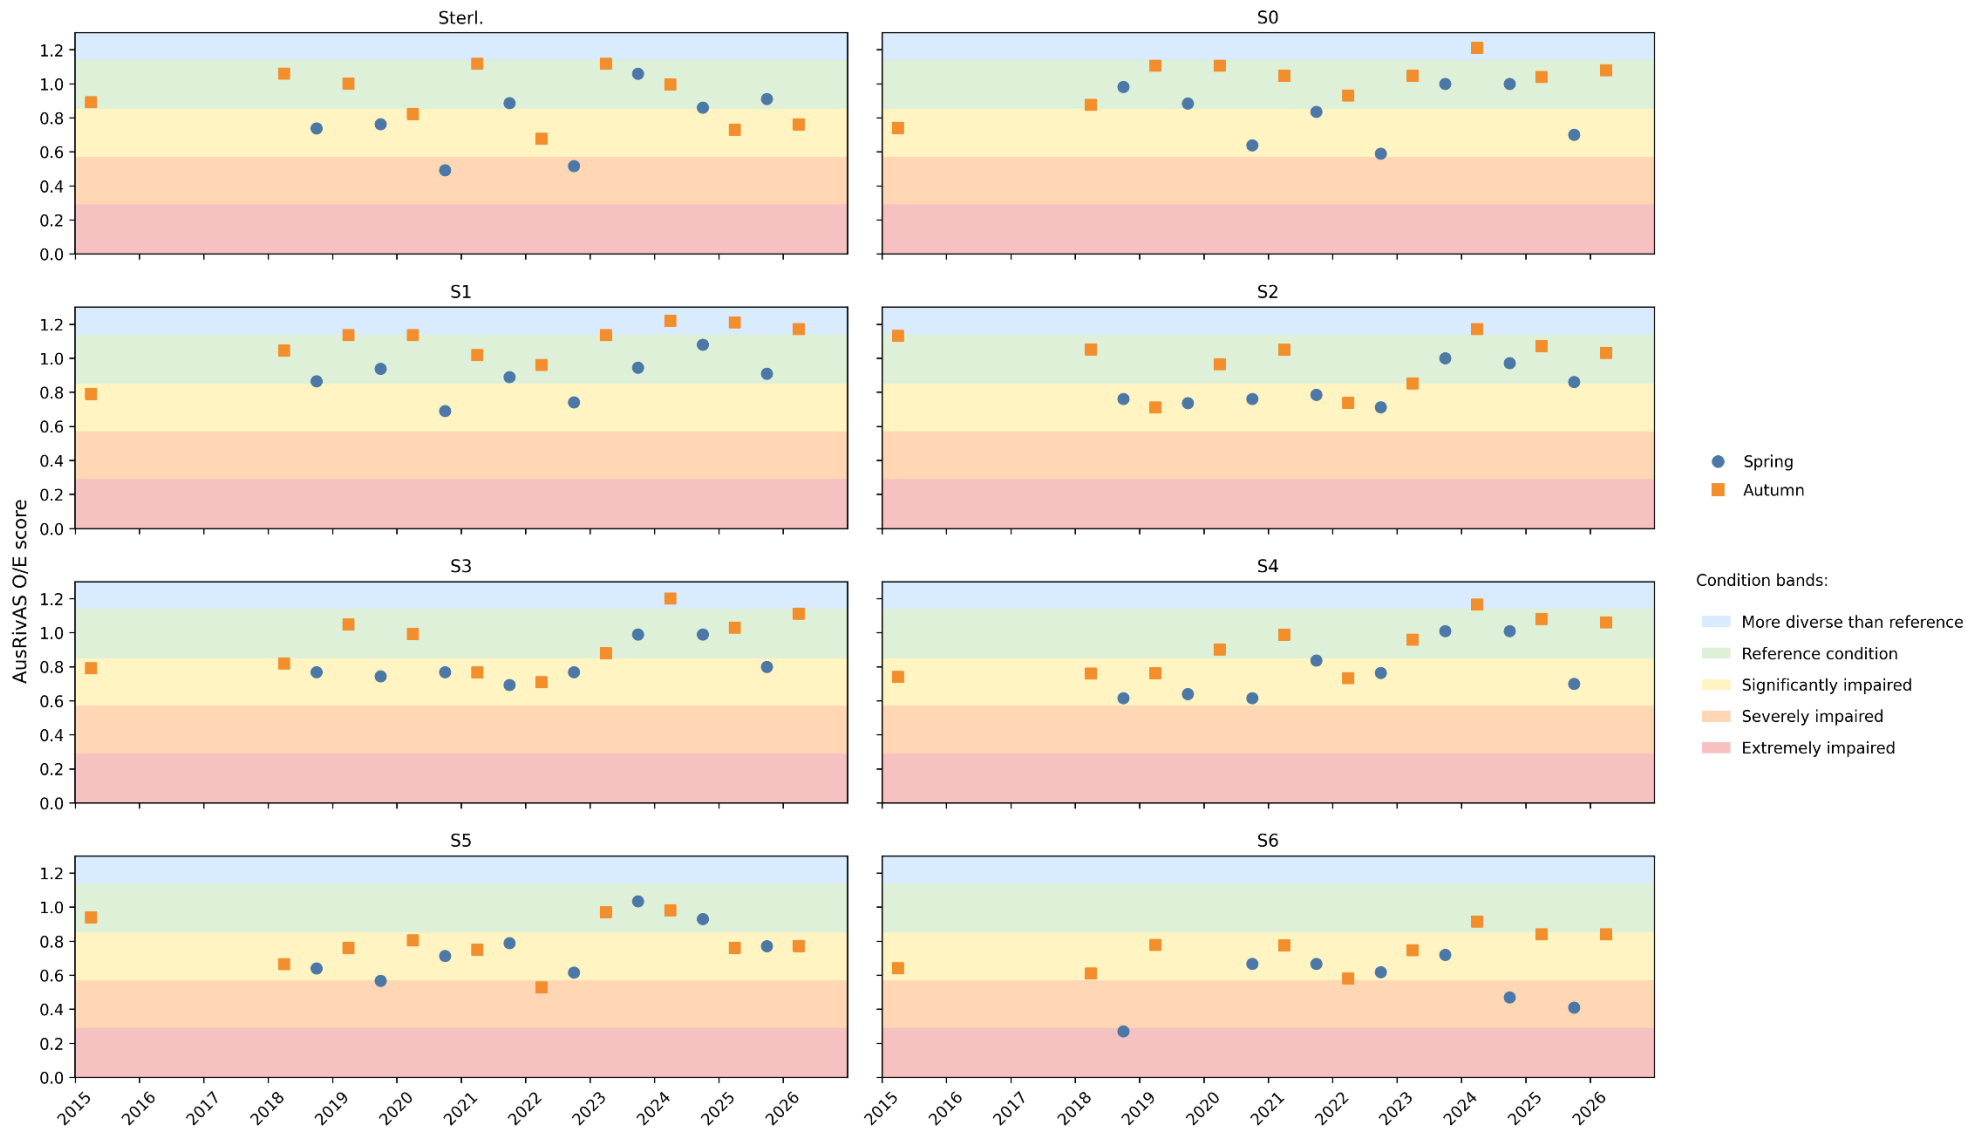
Figure 3.12: AusRivAS O/Epa model O/E scores and condition bands for the Sterling River and Stitt River site S0 from 2015 to 2026 (based on average score of two samples at each site).

The Sterling River reference site has been within the reference-condition range (band A) on 10 of 18 sampling occasions since 2015, within the significantly impaired range (band B) on six occasions, and within the severely impaired range (band C) on two occasions (Figure 3.12). The relatively frequent impaired ratings at this unregulated reference site are unusual, as there are no obvious catchment impacts that would explain the reduced condition. This includes the band B rating recorded during the most recent survey in autumn 2026.

Site S0 in the Stitt River has been within reference condition, or more diverse than reference, on 14 of 18 occasions and within the significantly impaired range on four occasions (Figure 3.12). Site S1 has been within reference condition, or more diverse than reference, on 15 of 18 occasions and within the significantly impaired range on three occasions. Site S2 has been within reference condition, or more diverse than reference, on 10 of 18 occasions and within the significantly impaired range on eight occasions.

Each of sites S3 and S4 has been within reference condition, or more diverse than reference, on eight of 18 occasions and within the significantly impaired range on 10 occasions (Figure 3.12). The impaired condition recorded at both sites in spring 2025 was the first since spring 2023.

Site S5 has most commonly been within the significantly impaired range but was assessed as equivalent to reference condition in 2015 and on four consecutive sampling occasions during 2023 and 2024. The site subsequently returned to band B during the three surveys from autumn 2025 to autumn 2026 (Figure 3.12).

A seasonal pattern was apparent in the historical AusRivAS results, with O/E scores consistently higher in autumn than in spring at all sites other than S5 (Figure 3.12). Although autumn O/E scores were generally higher than spring scores, considerable variation also occurred among years within each season.

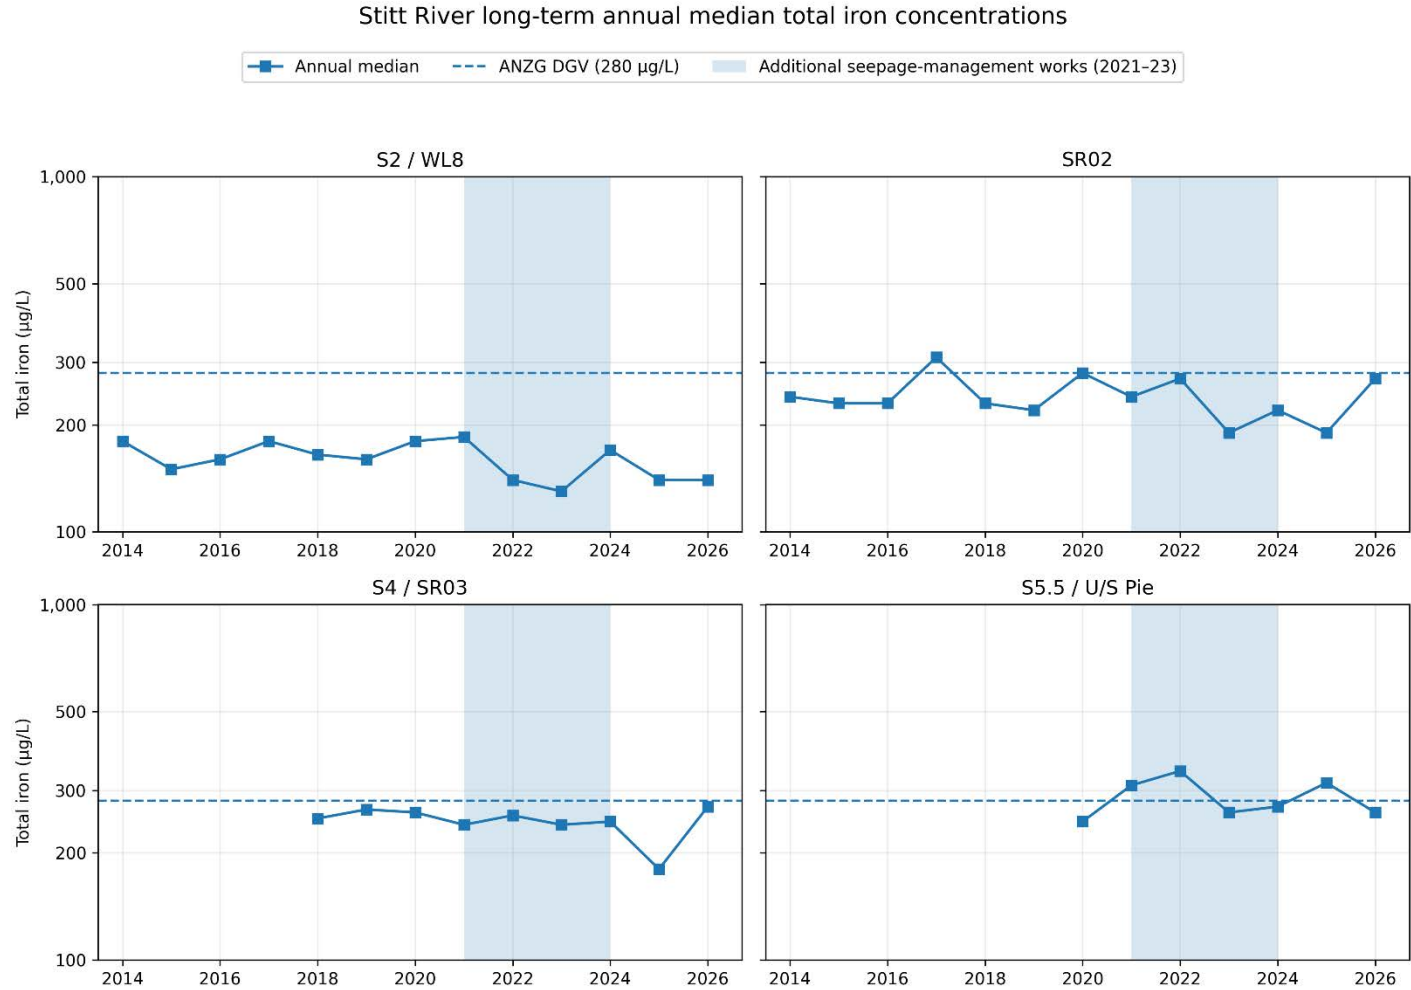
Figure C.3: Long-term annual median total iron concentrations (log) at selected Stitt River monitoring sites. Dashed horizontal lines indicate the applicable ANZG 95% freshwater default guideline values, and the shaded period indicates the additional 2/5 Dam TSF seepage-management works undertaken during 2021–23.

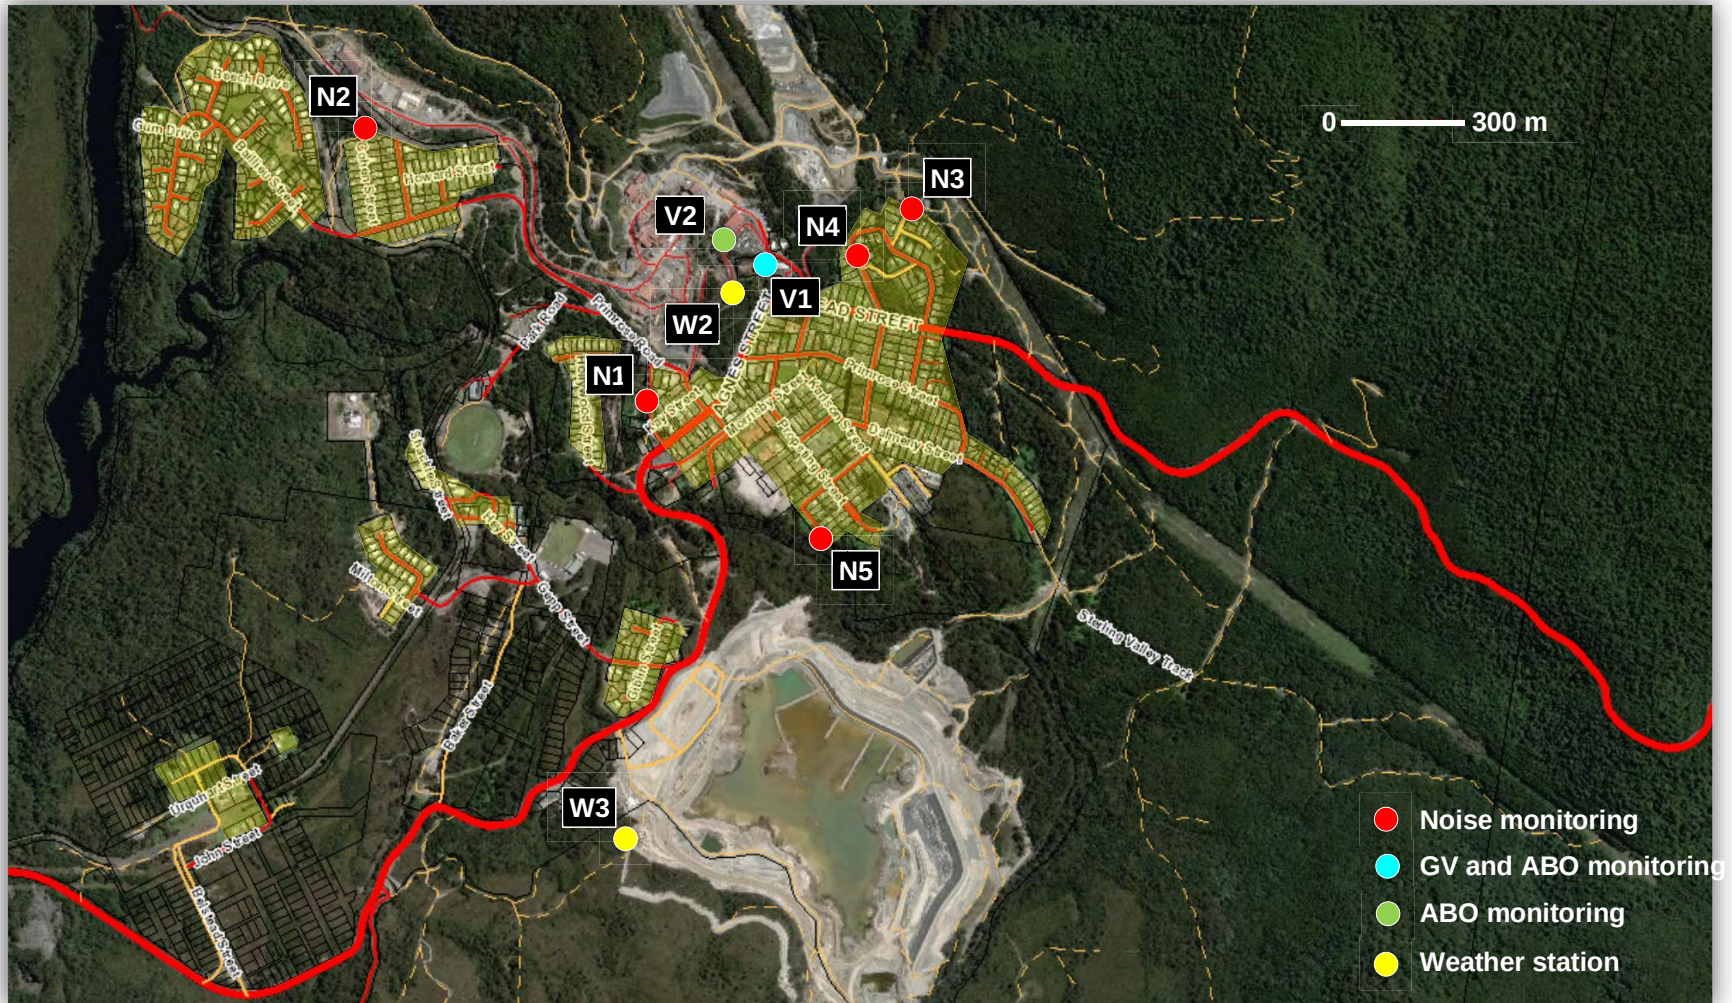
Figure 2-2: Aerial view of Rosebery with environmental noise; GV and ABO; and weather monitoring locations marked.
