Environmental Management Plan Review 2016-2021

MMG Rosebery

November 2021

Includes 2020-21 Annual Monitoring Review and Management Report and 5-yearly Monitoring System Reviews

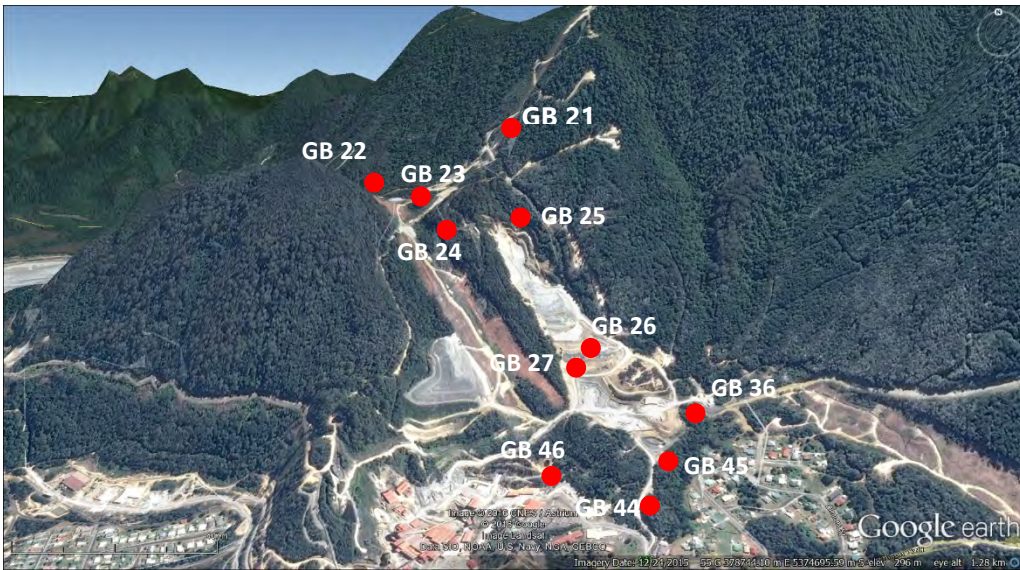
| REQUIREMENT | FINDINGS |
|--|---|
| Compliance with EPN – Assessment of groundwater impacts from the 3 Level WRD | <p>The EPN requires an assessment of groundwater impacts associated with 3 Level WRD. The relative position of the groundwater bores is shown in Figure 10.</p> <p>Monitoring results were within the range of previous results for pH, zinc, sulphate (Figure 11 - 17) and other metals.</p> <p>The results were generally similar in each bore for each monitoring period except in bore GB27 where total zinc in April 2021 was 1,920 mg/L, considerably higher than record in October (1,120 mg/L) and equivalent to the highest concentration recorded at the site.</p> <p>Bores near the top of the valley (GB21-GB25) continue to have higher pH and lower zinc and sulphate concentrations as compared to bores located downslope of the WRD and open cut; The bores at the base of the WRD (GB27, GB36, GB44, GB46) are characterised by low pH and elevated zinc and sulphate concentrations (Figure 6-10 to Figure 6-14). Bore GB27, located within the PAF material in the WRD has consistently recorded the highest concentrations with lead, manganese and zinc levels of almost 1-2 g/L and sulphate concentrations of ~10 g/L (Figure 11 – 17), and the lowest pH values.</p> <p>Water levels in the bores at sites upslope of the WRD (GB21, GB22, GB23) showed decreases between Oct/Nov and Apr/May of between 0.8 m and 1.1 m. Lower on the slope water level in GB24 and GB27 increased by 0.9 m and 0.2 m between the two sampling dates, respectively. At the base of the WRD bores GB36 and GB44 increased by <0.2 m. The largest change occurred in GB46 which increased by 1.24 m between Oct 2020 and April 2021. The water level results are consistent with regional groundwater in elevated areas decreasing over the summer months. The increase in level in the lower bores may reflect the higher than average rainfall which occurred in March and April 2021.</p> |

Figure 10. Vertically exaggerated view of 3L WRD showing approximate relative position of groundwater bores.

| REQUIREMENT | FINDINGS |
|--|---|
| Significant trends - longer period | <p>Bores GB23 continues to record elevated zinc (11-14 mg/L) and sulphate (103-126 mg/L) concentrations even though it is located well above the open cut and WRD. Identifying the source of this groundwater would be useful for understanding diffuse inputs to Rosebery Creek.</p> |

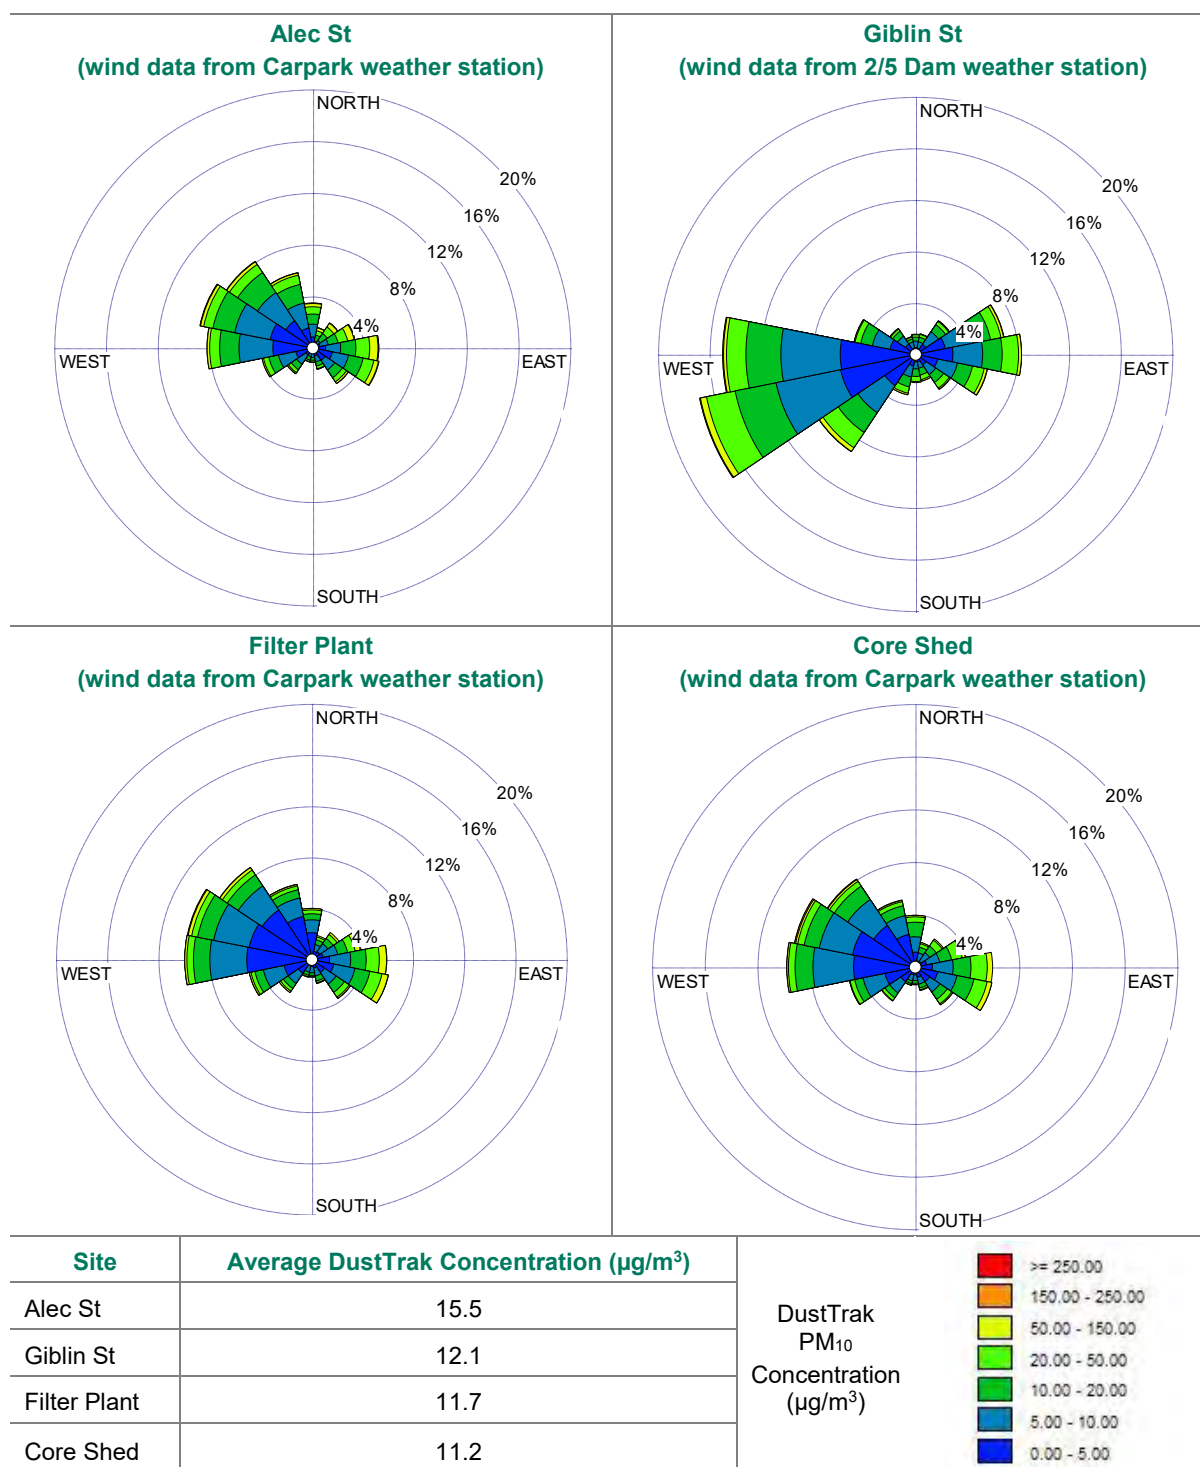
Figure 3.1: Pollution roses of DustTrak concentration

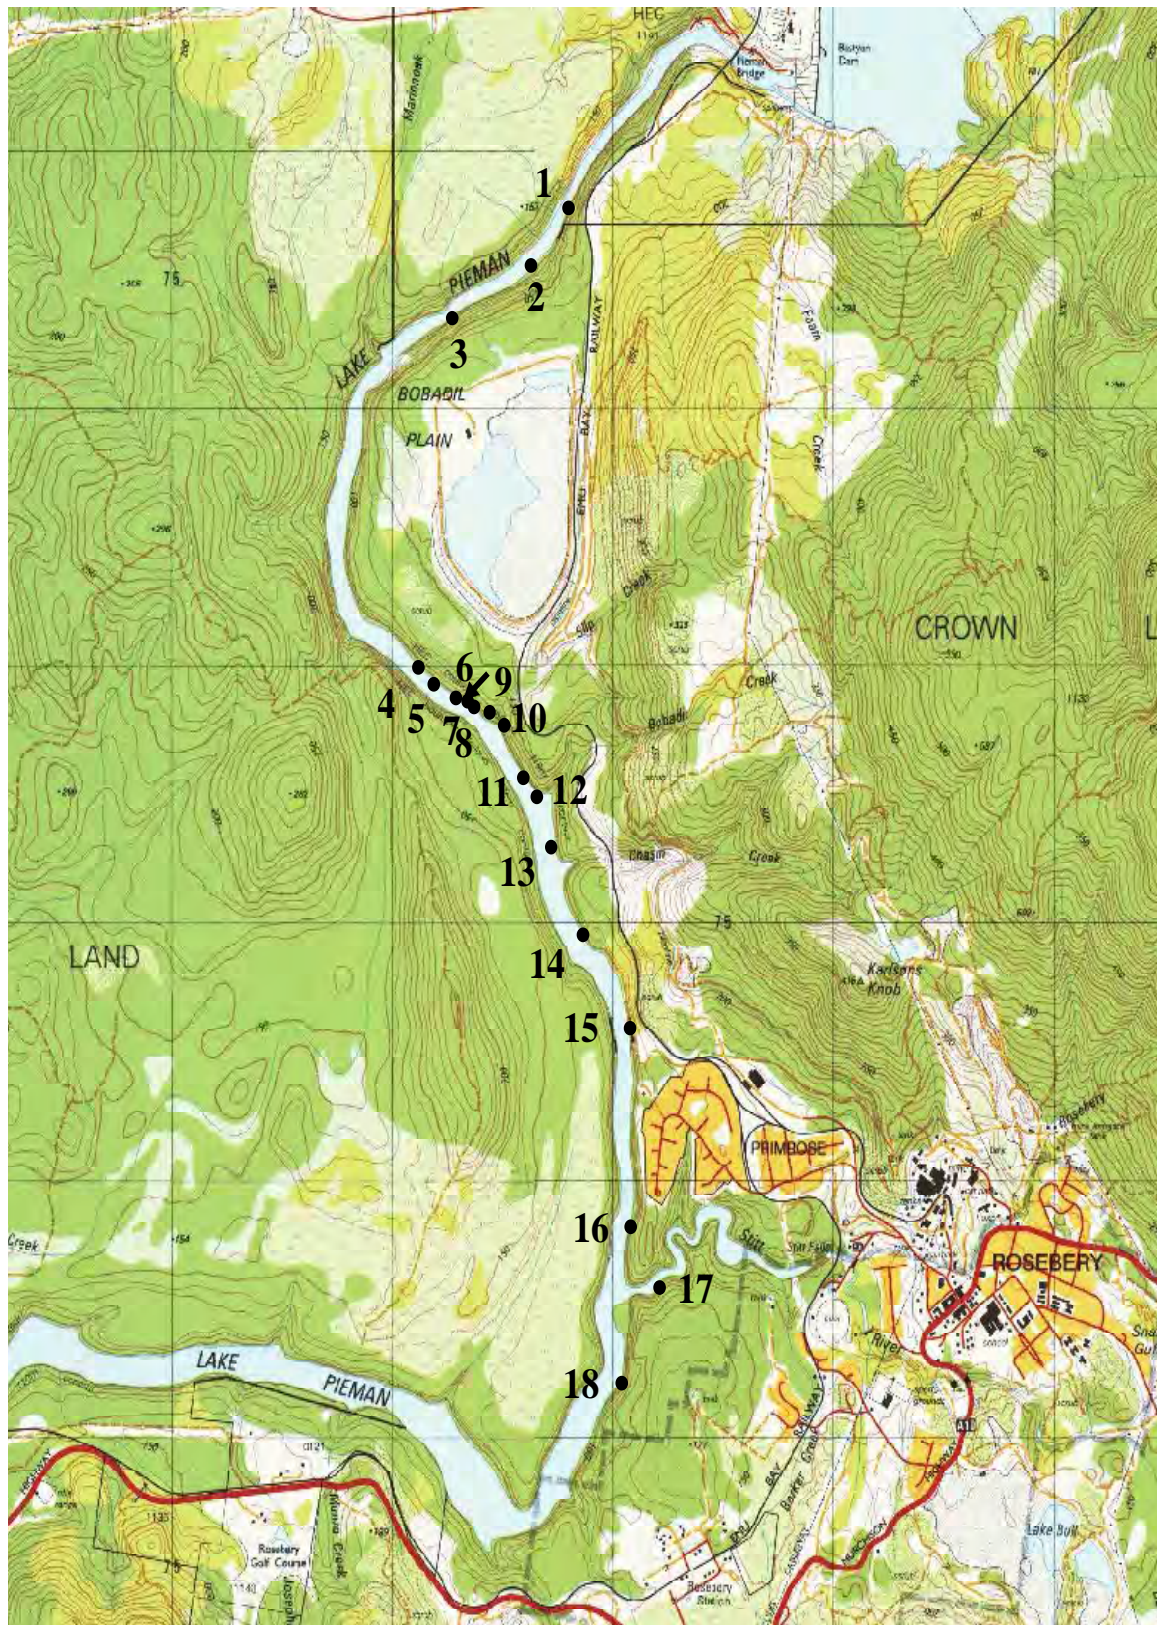
Figure 1. Location of sampling sites in Lake Pieman.

Black arrow indicates location of discharges for MMG at Bobadil. Sites 1-15 are MMG monitoring sites; sites 16-18 are the TasWater sites. 1:25000 map scale, grid squares = 1 km².

Sampling was conducted at the 15 MMG and 3 Taswater sites along the eastern shore zone (Figure 1, Table 1) on 23 October 2020. Sites 1-3 are

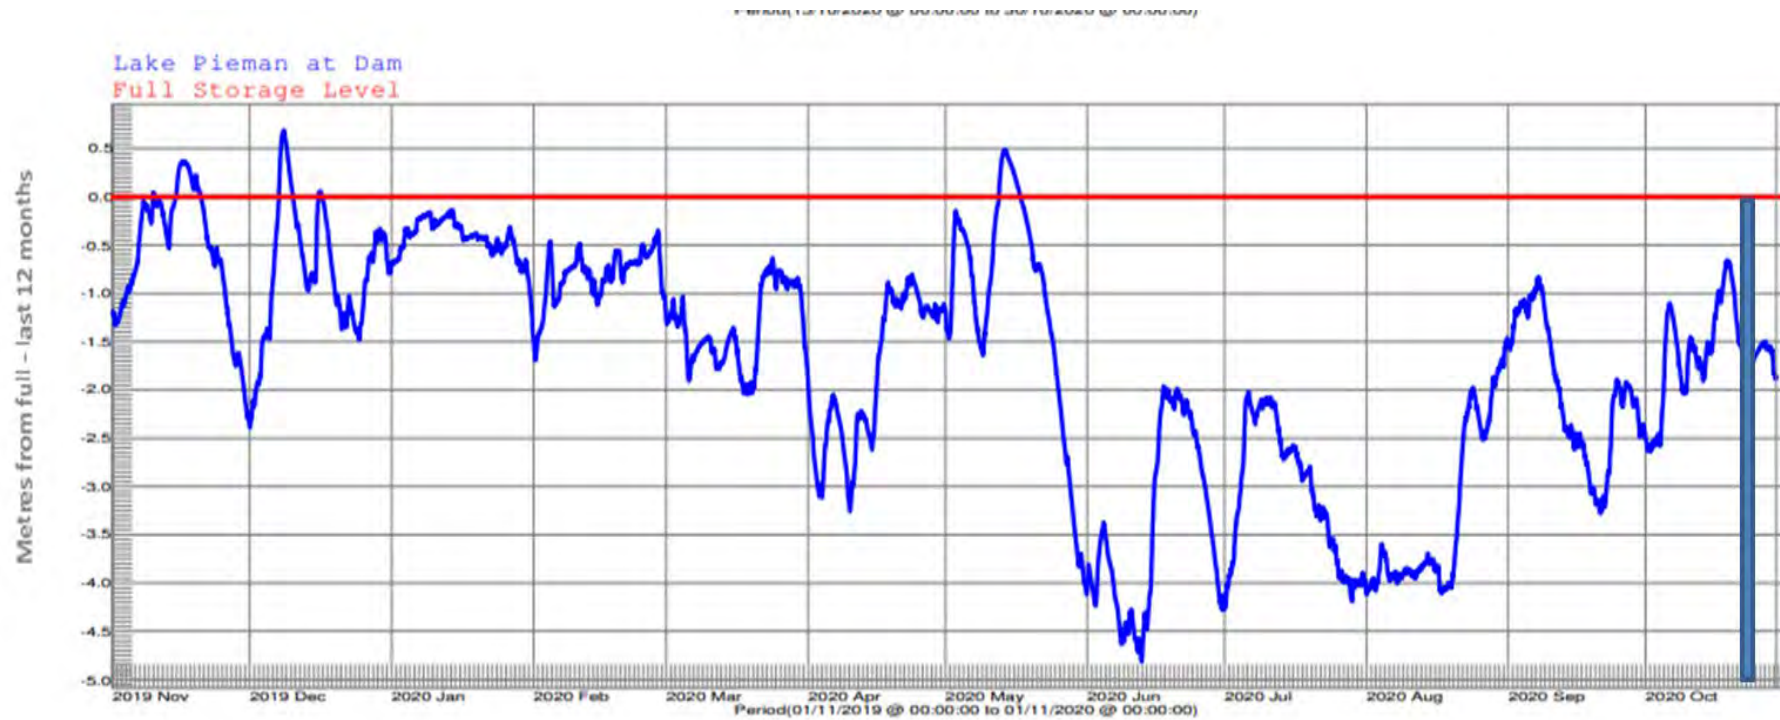
Figure 5. Lake Pieman levels in (a) 2018, (b) 2019, and (c) 2020. Sampling dates are shown by shaded bar. Source: Hydro Water: <https://www.hydro.com.au/water/lake-levels>.

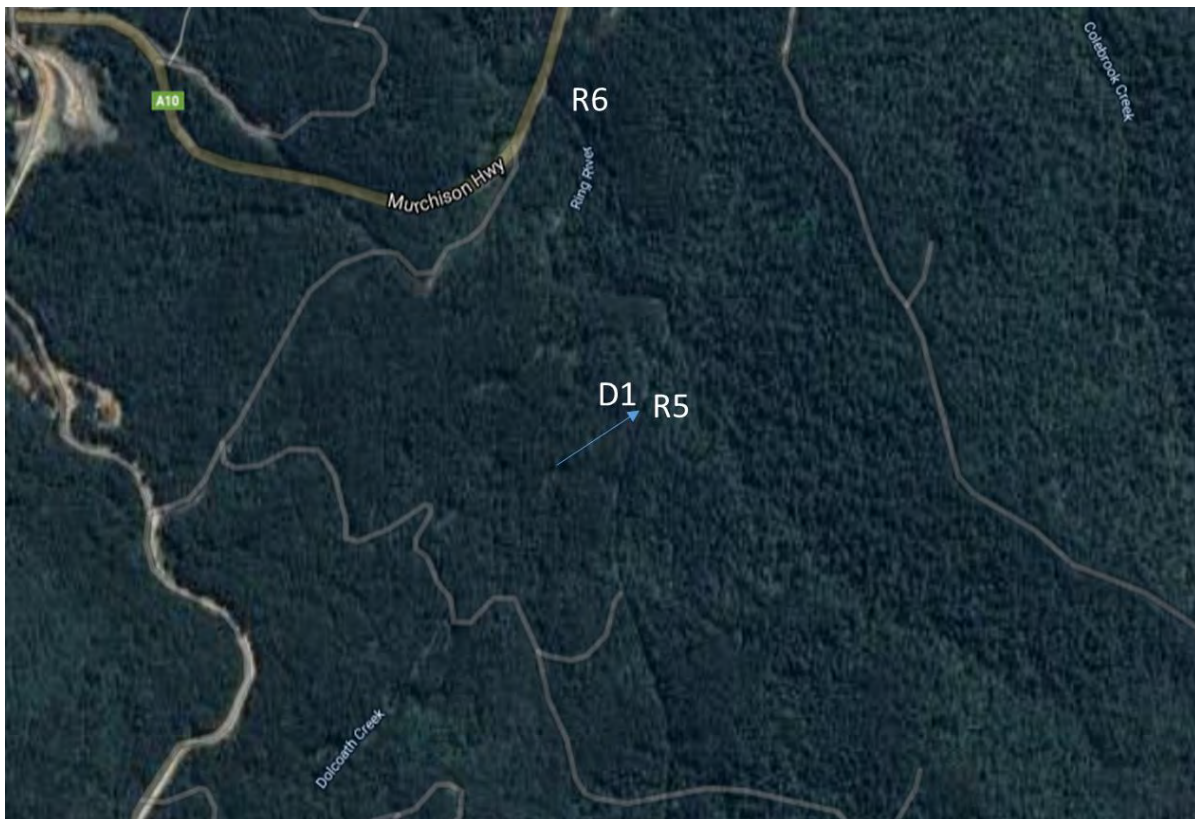
Figure 2b. Map of study sites in the lower Ring River catchment. Blue arrow shows point of confluence of Dolcoath Creek and the Ring River

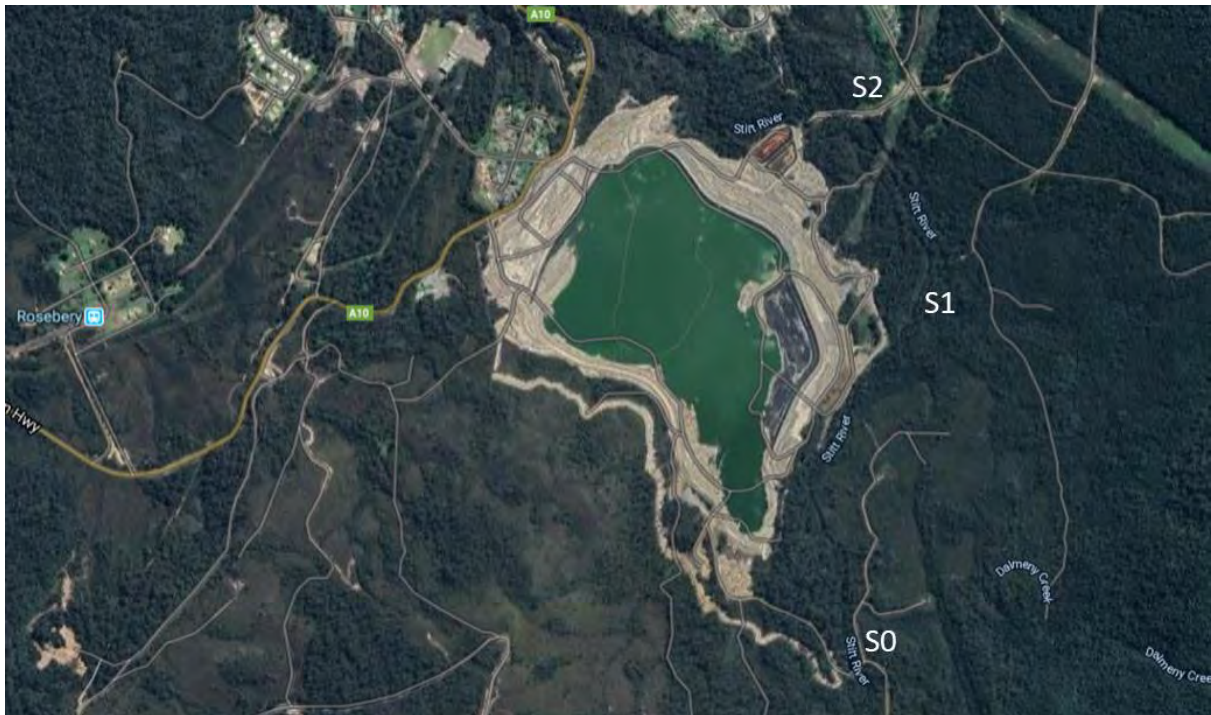
Figure 3a. Map of study sites in the upper Stitt River catchment.

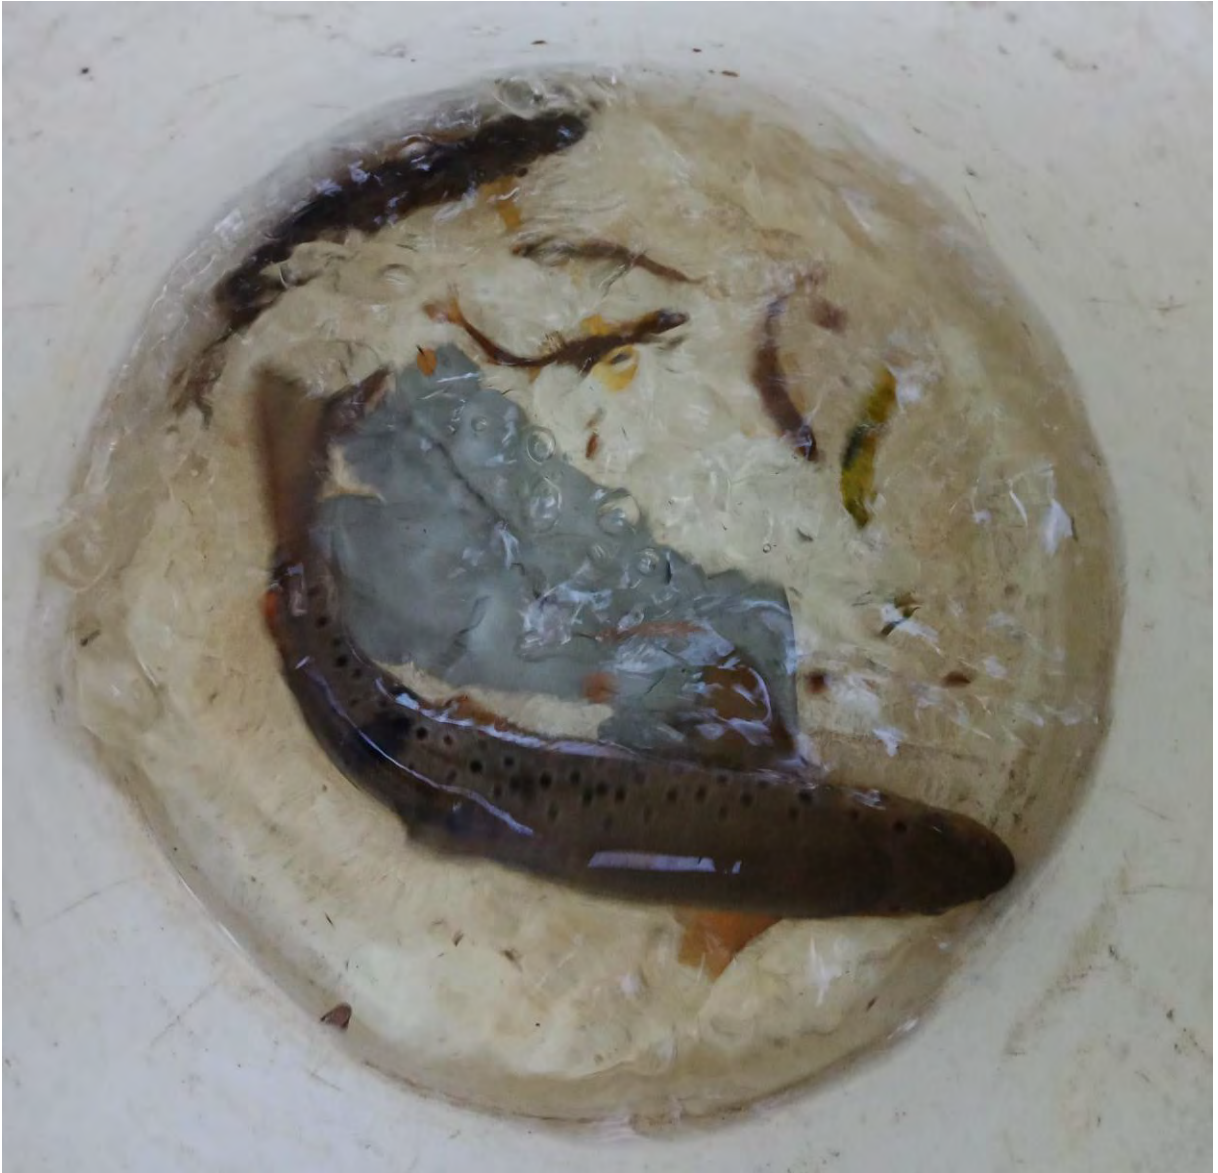
Figure 12. Adult and juvenile brown trout captured in the lower Stitt River (at site S5 at Footbridge).

Fish were surveyed in Stitt River sites S1 to S5 and in the Sterling River (Table 4). In spring 2020, adult brown trout were recorded at all Stitt Rivers sites down to and including S5, with juvenile trout also captured at Stitt River site S2 (Table 4). In autumn 2021, both adult and juvenile brown trout were recorded at all Stitt River sites (see Figure 12), with generally lower numbers captured in the lower reaches (Table 4). These data

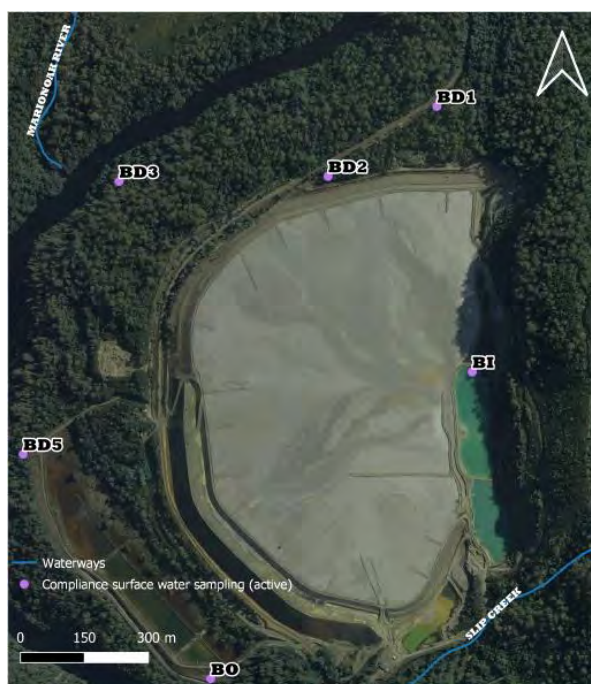
EPN 7153/3 includes a requirement to monitor seepage from the Bobadil Dam based on observations of seepage flows at the time of preparation of the EPN (Figure 4-1). The intention of seepage monitoring is to understand diffuse inputs to the environment from the TSF. Since that time, several lifts of the dam wall have been completed, and the sub-surface hydrology

Figure 4-1. Location of Bobadil Seeps at commencement of EPN 7153/3.

of the site has altered, as evidenced by the lack of flow in several historic seepage points. Other seeps have been eliminated by expansion of the TSF. A summary of the monitoring results from the Bobadil TSF seeps are contained in Table 4-1.

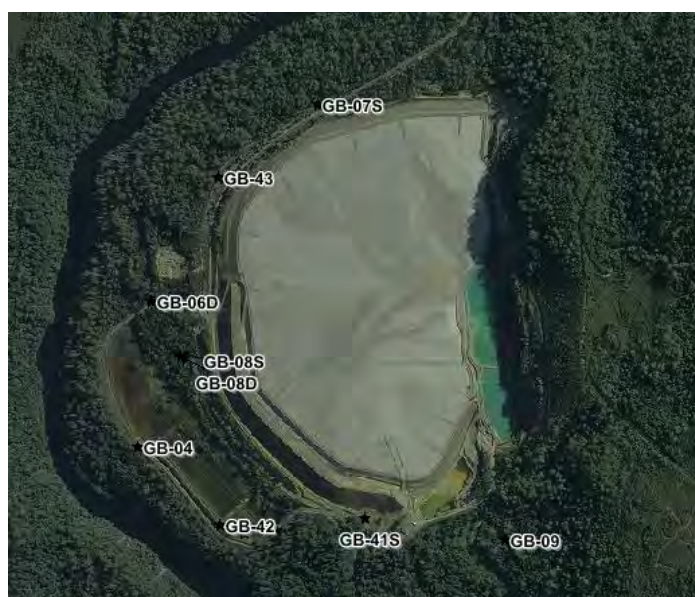
The location of groundwater monitoring bores near the Bobadil TSF is shown in Figure 5-1, and a summary of groundwater monitoring results is contained in Table 5-1.

Figure 5-1. Location of groundwater monitoring bores near the Bobadil TSF. Note, GB41, GB42 and GB43 are not included in the requirements for the annual review, but are part of the groundwater network managed by MMG.

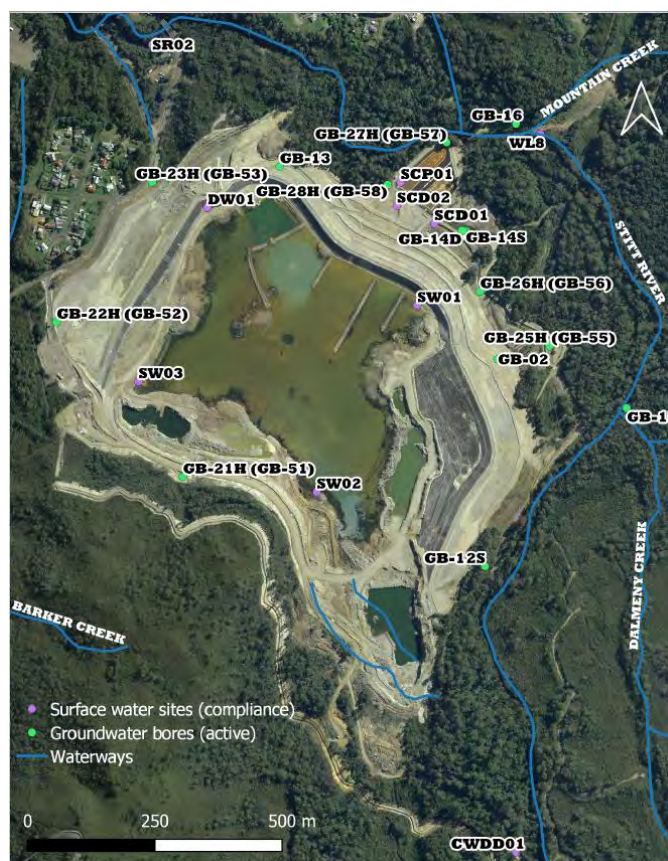
During the 2020-2021 monitoring year there were no unintentional discharges from the 2/5 TSF into the Stitt River. Compliance water quality monitoring is based on the sites listed in Table 6-1 and Figure 6-1, and monitoring compliance is summarised in Table 6-2.

Figure 6-1. Monitoring locations at the 2/5 TSF following redevelopment. SR03 and U/S Pie are located downstream of SR02, off of the photo.

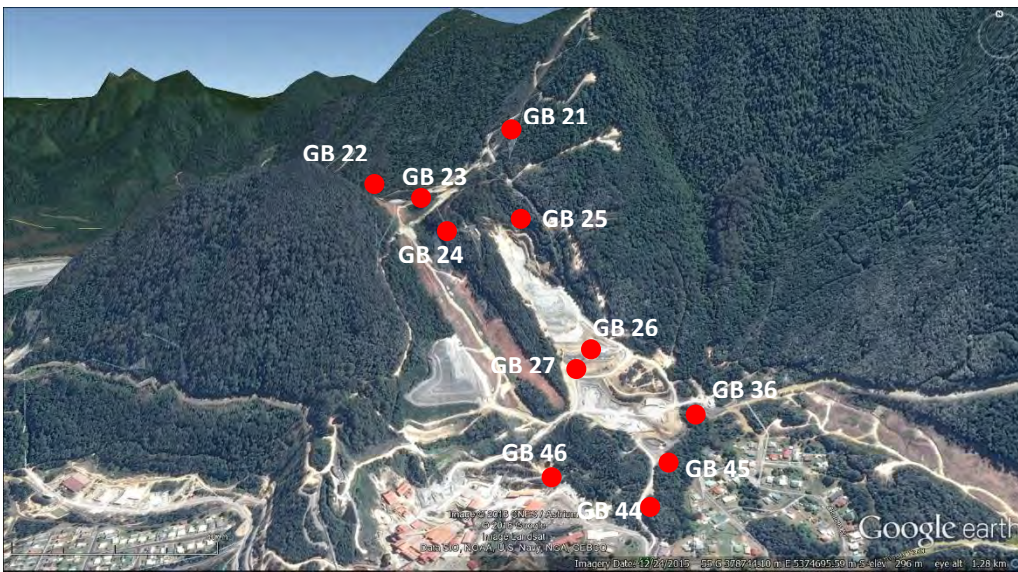
| Compliance with EPN – Assessment of groundwater impacts from the 3 Level WRD | <p>The EPN requires an assessment of groundwater impacts associated with 3 Level WRD. The relative position of the groundwater bores is shown in Figure 13-8.</p> <ul style="list-style-type: none"> Monitoring results were within the range of previous results for pH, zinc, sulphate (Figure 13-10 to Figure 13-14) and other metals. The results were generally similar in each bore for each monitoring period except in bore GB27 where total zinc in April 2021 was 1,920 mg/L, considerably higher than record in October (1,120 mg/L) and equivalent to the highest concentration recorded at the site. Bores near the top of the valley (GB21-GB25) continue to have higher pH and lower zinc and sulphate concentrations as compared to bores located downslope of the WRD and open cut; The bores at the base of the WRD (GB27, GB36, GB44, GB46) are characterised by low pH and elevated zinc and sulphate concentrations (Figure 13-10 to Figure 13-14). Bore GB27, located within the PAF material in the WRD has consistently recorded the highest concentrations with lead, manganese and zinc levels of almost 1-2 g/L and sulphate concentrations of ~10 g/L (Figure 13-15), and the lowest pH values. Water levels in the bores at sites upslope of the WRD (GB21, GB22, GB23) showed decreases between Oct/Nov and Apr/May of between 0.8 m and 1.1 m. Lower on the slope water level in GB24 and GB27 increased by 0.9 m and 0.2 m between the two sampling dates, respectively. At the base of the WRD bores GB36 and GB44 increased by <0.2 m. The largest change occurred in GB46 which increased by 1.24 m between Oct 2020 and April 2021. The water level results are consistent with regional groundwater in elevated areas decreasing over the summer months. The increase in level in the lower bores may reflect the higher than average rainfall which occurred in March and April 2021. |
| <p>Figure 13-8. Vertically exaggerated view of 3L WRD showing approximate relative position of groundwater bores.</p> | |

Bores GB23 continues to record elevated zinc (11-14 mg/L) and sulphate (103-126 mg/L) concentrations even though it is located well above the open cut and WRD. Identifying the source of this groundwater would be useful for understanding diffuse inputs to Rosebery Creek.

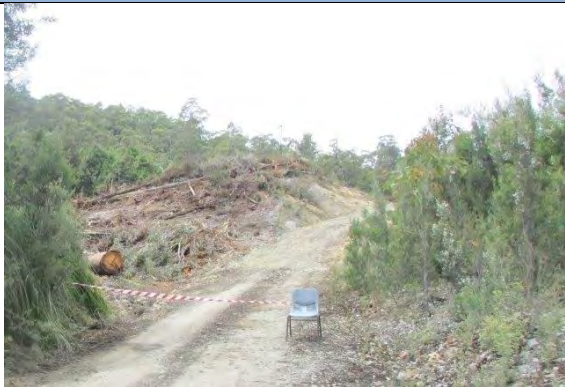
| Environmental Protection Notice Schedule & Condition | Status | Supporting Evidence/Comments/Photographs |
|--|---|---|
| | | <p>Photo No. 2 – Entrance to the MMG Rosebery Bobadil 2021 Borrow Area (December 2020)</p> <p><u>2019/20 Weed Eradication Programs</u></p> <p>MMG Rosebery continue to budget and implement annual strategies for weed management. Over the last few years, improvements to weed management across the operation was able to be demonstrated.</p> <p>The 2019/20 annual weed spraying program occurred as scheduled and involved one main weed spraying program and one follow up weed spraying program). It was stated that all sprayed weed waste is transported and disposed at the Zeehan landfill.</p> <p>Weed spraying is also scheduled and completed annually for the Hercules and South Hercules mine areas.</p> <p>In November 2020, MMG Rosebery developed scopes of work (i.e. CPORTS) for the a) late 2020/April 2021 weed spraying program and b) the 2021 Pampas Grass Eradication Program (i.e. for external service provider, GBE Maintenance Services Pty Ltd, based in Zeehan).</p> <p><u>Weed Procedures and Data Management</u></p> <p>As of December 2020, MMG Rosebery continue to maintain a:</p> <ul style="list-style-type: none"> • Weed and Pathogen Washdown Procedure (last issued 6th August 2019). • Weed Management Procedure (last issued 10th April 2019) <p>Both above procedures are current and available on the MMG Rosebery Library.</p> |

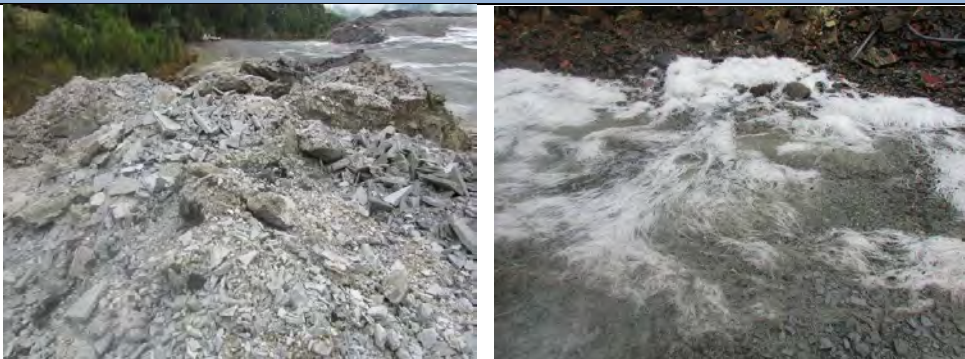
| Environmental Protection Notice Schedule & Condition | Status | Supporting Evidence/Comments/Photographs |
|--|---|---|
| | | <p>Photos No. 4 and 5 – Unauthorised deposition of waste concrete, minor volumes of waste “shotcrete fibres” and contaminated soil at 3 Level WRD (December 2020)</p> |

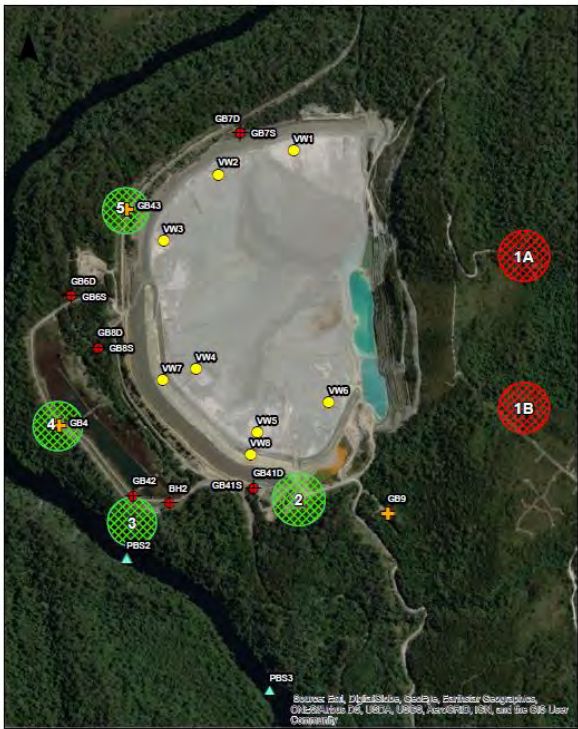
| Environmental Protection Notice Schedule & Condition | Status | Supporting Evidence/Comments/Photographs |
|--|---|---|
| | | <p>Photo No. 6 - Bobadil Groundwater Monitoring Bore Installation Program (2020)</p> <p>These 10 new groundwater monitoring bores were installed in two phases in June and December 2020. The final installation report is scheduled to be completed and issued after these bores are surveyed in March 2021.</p> <p><u>General Rosebery Groundwater Monitoring Program</u></p> <p>During the audit period, MMG Rosebery maintained a formal program of scheduled groundwater monitoring at six monthly intervals. Sampling continues to be conducted by external service providers, ES&D for approximately 50 groundwater monitoring bores at six monthly intervals. For</p> |

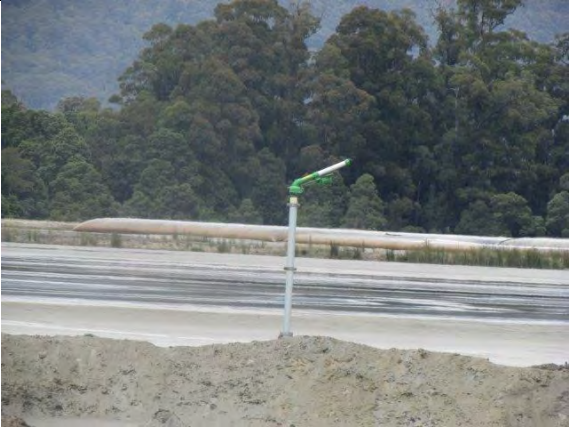
| Environmental Protection Notice Schedule & Condition | Status | Supporting Evidence/Comments/Photographs |
|--|---|---|
| | | <p>Photo No. 7 – Existing sprinkler system at the Bobadil TSF (December 2020)</p> <p>MMG Rosebery recommenced the discharge of tailings to Bobadil in late 2019 for fixed periods of time every 2nd or 3rd day for the last 12 months (i.e. as the dam capacity is restricted until the Stage 10 embankment is complete).</p> <p>It was stated that no dust complaints have been received from the operation of the 2/5 dam in the last 16 months (i.e. given few vehicle movements occur at this location). Some vegetation has commenced growing on the vacant area located near the spillway (i.e. this area is utilised for flood control). In addition, preliminary planting of vegetation was completed on the screening wall between the Murchison Highway and 2/5 dam.</p> |

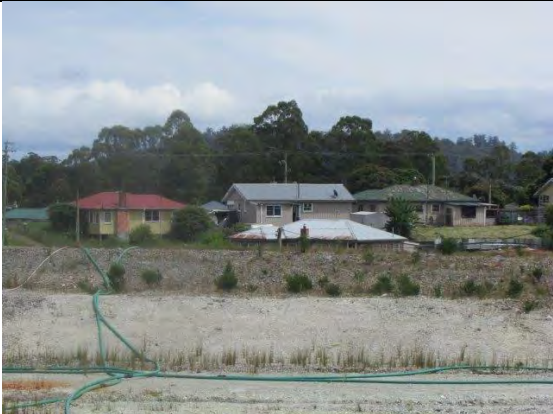
| Environmental Protection Notice Schedule & Condition | Status | Supporting Evidence/Comments/Photographs |
|--|---|--|
| | | <div data-bbox="1256 323 1807 738" data-label="Image"> </div> <p data-bbox="1070 754 1995 778">Photo No. 8 – Vegetation growth on previously disturbed land near the 2/5 dam (December 2020)</p> <p data-bbox="1008 798 1122 821"><u>2019/2020</u></p> <p data-bbox="1008 841 2047 922">During the 2019/20 audit period, no additional improvements or capital were committed for fugitive dust abatement in the last 16 months (i.e. only the purchase and installation of the DRX dust monitoring units).</p> <p data-bbox="1008 941 2018 1023">No additional sealing works have occurred within or around the operation in the last 16 months, with the objective of reducing dust emissions. It was stated that MMG Rosebery are considering additional resealing of roadways around the warehouse in 2021 (i.e. for safety reasons).</p> <p data-bbox="1008 1042 2038 1094">Dust suppression systems utilising sprays continue to be used at the crusher and coarse ore bins (i.e. these are automatically triggered when truck movements are detected).</p> <p data-bbox="1008 1114 2009 1166">All conveyors across the Rosebery operation remain covered to reduce fugitive dust emissions from these sources.</p> |

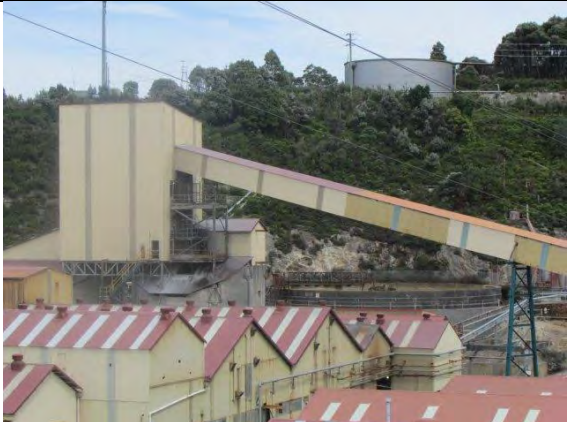
| Environmental Protection Notice Schedule & Condition | Status | Supporting Evidence/Comments/Photographs |
|--|---|--|
| | | <p>Photo No. 9 – Covered conveyor systems within the MMG Rosebery Processing Plant (December 2020)</p> <p>If needed, water carts remain available at the operation (i.e. normally utilised underground) for dust abatement of unsealed surfaces (i.e. ROM area, waste rock dumps/mining areas). These would typically be used if a community complaint was received or if adverse weather conditions were forecast. This is the dedicated water truck for underground and can be used on the surface as required.</p> <p>For the last 16 months, MMG Rosebery Pit Ram receive the dust alerts and can respond as required to try and target and address the source of any adverse dust emissions.</p> <p>MDG also have a registered water truck that can be utilised for areas around MMG Rosebery's processing area as and when needed. Gradco also utilise a water cart to minimise construction related dust during the Stage 10 lift in 2020/21 at the Bobadil TSF.</p> |

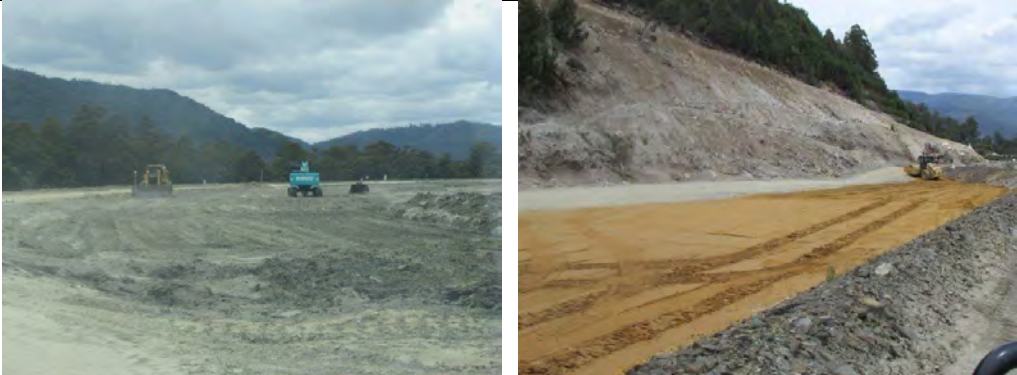
| Environmental Protection Notice Schedule & Condition | Status | Supporting Evidence/Comments/Photographs |
|--|---|--|
| | | <p>Photos No. 10 and 11 – Stage 10 Embankment Construction at Bobadil TSF (December 2020)</p> <p>Apart from the above, few additional opportunities existed for dust abatement across the operation in 2019/20.</p> |

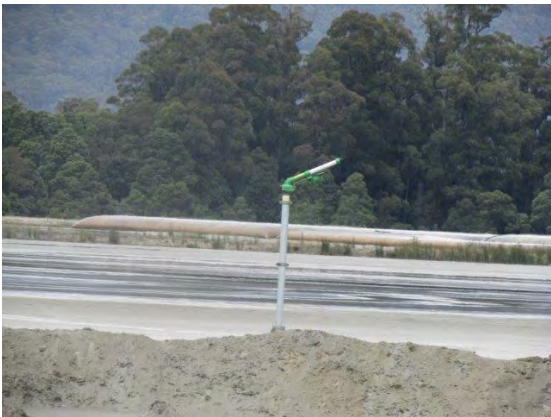
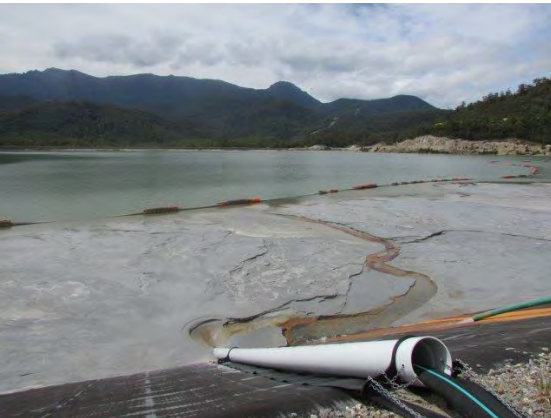
| Environmental Protection Notice Schedule & Condition | Status | Supporting Evidence/Comments/Photographs |
|--|---|---|
| | | <div data-bbox="1256 336 1805 754" data-label="Image"> </div> <p data-bbox="1084 767 1980 794">Photo No. 12 – Operational sprinklers on the surface of the Bobadil TSF (16th December 2020)</p> <div data-bbox="1256 809 1805 1228" data-label="Image"> </div> <p data-bbox="1034 1246 2029 1294">Photo No. 13 – High quality beaching of tailings was observed at 2/5 Dam that were not observed to be a source of fugitive dust (16th December 2020)</p> |

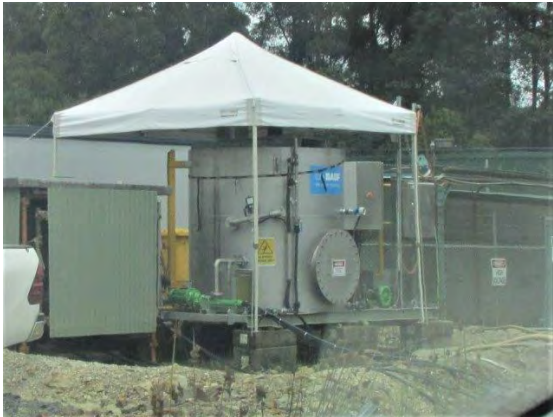
| Environmental Protection Notice Schedule & Condition | Status | Supporting Evidence/Comments/Photographs |
|--|---|--|
| | | <p>MMG Rosebery commissioned flocculant addition at the Bobadil dam in Q4 2019 (i.e. to facilitate the operation of the existing geotubes for the desilting of the Bobadil polishing ponds) (Photo No. 14).</p> <p>Photo No. 14 – Stainless steel flocculant tank in use at Bobadil (16th December 2020)</p> |

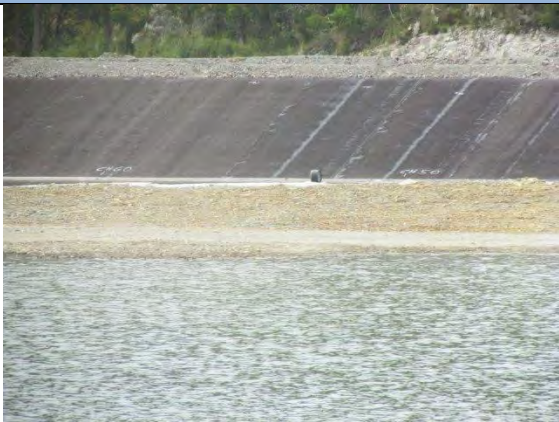
| Environmental Protection Notice Schedule & Condition | Status | Supporting Evidence/Comments/Photos |
|---|---|---|
| | | <p>Photo No. 16 – Location of the eastern embankment of the 2/5 Dam Tailings Storage Facility that required liner repairs (16th December 2020).</p> |

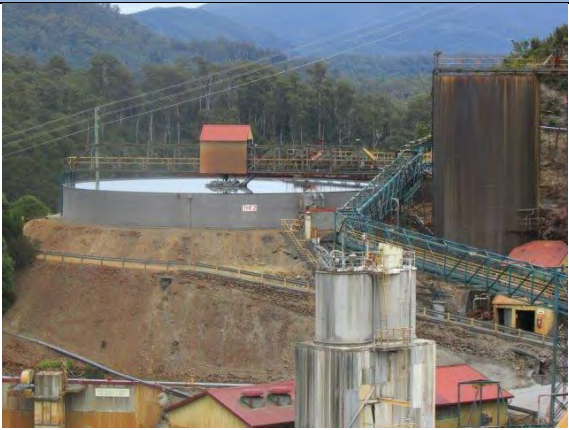
| Environmental Protection Notice Schedule & Condition | Status | Supporting Evidence/Comments/Photos |
|--|---|---|
| | | <div data-bbox="1249 320 1816 751" data-label="Image"> </div> <p data-bbox="1272 762 1794 791">Photo No. 17 – MMG Rosebery ETP (December 2020)</p> <p data-bbox="1010 807 1122 836"><u>Filter Plant</u></p> <p data-bbox="1010 852 2054 1018">One environmental incident occurred at the MMG Rosebery filter plant in the last 16 months. This involved one accidental release of stormwater to the environment that coincided with a high rainfall event between the 18th and 22nd August 2019. The event resulted in a spill of water from the Filter Plant Cell #2 that contained copper and lead in excess of the 95th percentile investigative values and zinc in excess of the discharge limit at BO. This event was reported to the EPA and a summary report was provided in September 2019.</p> |

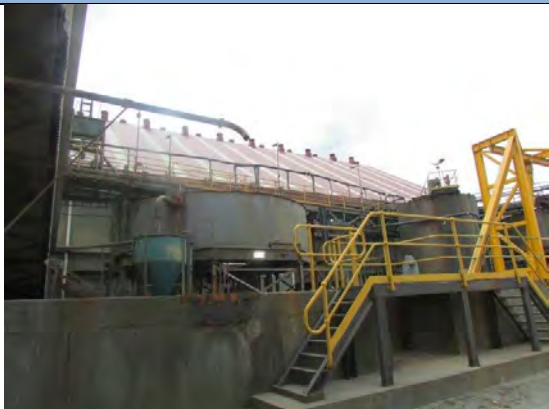
| Environmental Protection Notice Schedule & Condition | Status | Supporting Evidence/Comments/Photos |
|--|---|---|
| | | <div data-bbox="1258 320 1805 730" data-label="Image"> </div> <p data-bbox="1240 746 1823 772">Photo No. 18 – MMG Rosebery Filter Plant (December 2020)</p> <p data-bbox="1008 790 1218 815"><u>4 Level Surge Pond</u></p> <p data-bbox="1008 833 1756 858">No incidents occurred at the 4 Level Surge Pond in the last 16 months.</p> <p data-bbox="1008 876 1218 901"><u>8 Level Surge Pond</u></p> <p data-bbox="1008 919 1756 944">No incidents occurred at the 8 Level Surge Pond in the last 16 months.</p> <p data-bbox="1008 962 2047 1074">The Level 8 surge pond continues to be utilised as required during periods of mill shutdown and during high rainfall events. This surge pond facility includes a functional level sensor, which continuously displays pond levels in the mill control room. This facility has never overtopped since its construction.</p> |

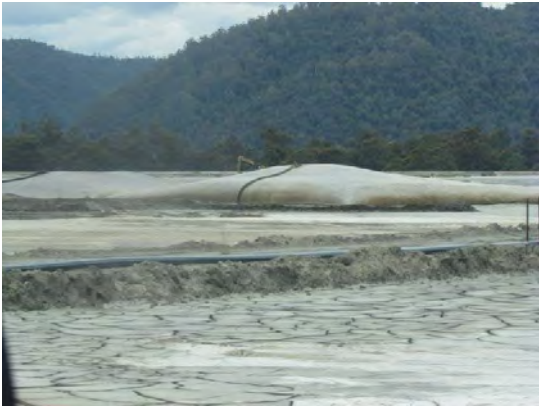
| Environmental Protection Notice Schedule & Condition | Status | Supporting Evidence/Comments/Photos |
|--|---|---|
| | | <div data-bbox="1263 320 1800 727"> </div> <p data-bbox="1263 740 1800 767">Photo No. 19 – Level 8 Surge Pond (16th December 2020)</p> <p data-bbox="994 783 1285 810"><u>Polishing Ponds (Bobadil)</u></p> <p data-bbox="994 826 2067 938">As of December 2020, the Bobadil Polishing Ponds were in the process of being desilted. Desilting operations commenced in January 2020 and is expected to be completed by mid-2021. Settled material from these ponds is being deposited in Geo-tubes located on the surface of the Bobadil TSF.</p> <div data-bbox="1263 954 1800 1361"> </div> |

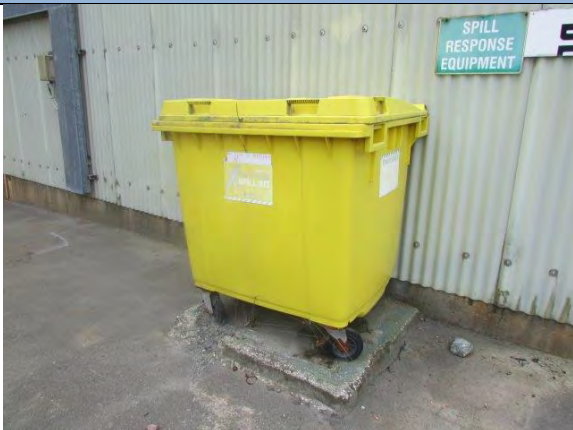
| Environmental Protection Notice Schedule & Condition | Status | Supporting Evidence/Comments/Photographs |
|--|---|--|
| | | <p>Photo No. 24 – Example of jumbo spill kit near the chemical reagent shed (December 2020)</p> <p>MMG Rosebery's warehouse retains adequate stocks of spill kit contents, which are replaced as needed.</p> <p>The availability and maintenance of spill kits was stated to be the responsibility of area owners (i.e. to ensure that these are correctly maintained and sufficiently stocked). Relevant mining personnel are responsible for managing the availability and restocking of spill kits underground.</p> <p>It was stated that only minor spills have occurred across the operation and underground in the last 16 months, inclusive of some minor diesel spills in 2019/20 that required the use of some stocks from these kits.</p> <p>It was stated that the on-site MMG Rosebery MDG and off-site Veolia vacuum truck remain available for any major spill clean-up, which was not required for any spill or emergency situation in the last 16 months.</p> |

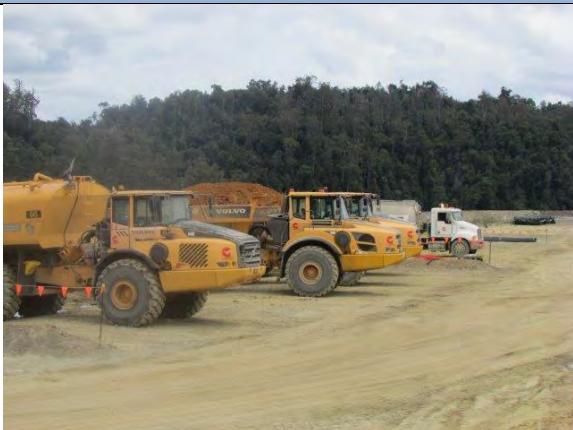
| Environmental Protection Notice Schedule & Conditions | Status | Supporting Evidence/Comments/Photographs |
|---|---|--|
| | | <p>Photo No. 25 – Earthmoving equipment for the Stage 10 Bobadil embankment lift (16th December 2020)</p> <p>The management and operation of the Bobadil and 2/5 dams continue to be the responsibility of MMG Rosebery's Processing Superintendent. At the time of this audit, MMG Rosebery was in the process of appointing a Superintendent – Tailings and Water, with responsibilities for both tailings storage facilities.</p> <p>At the time of this December 2020 audit, no tailings generated by MMG Rosebery were being used or placed underground as backfill material.</p> |

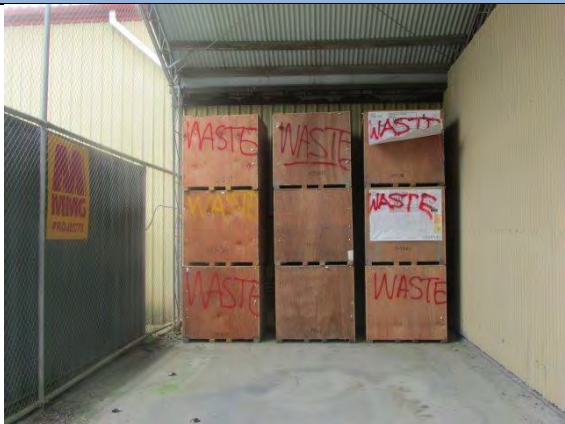
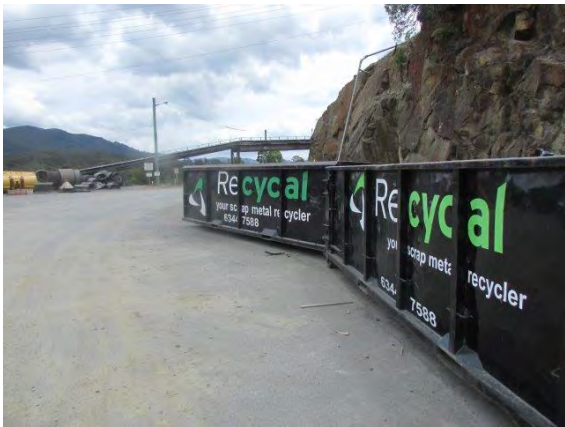
| Environmental Protection Notice Schedule & Conditions | Status | Supporting Evidence/Comments/Photographs |
|---|---|--|
| | | <div data-bbox="1249 320 1812 745" data-label="Image"> </div> <p data-bbox="1032 762 2029 810">Photo No. 27 – Empty waste cyanide boxes and bags securely stored at MMG Rosebery (16th December 2020)</p> <p data-bbox="1005 831 2029 879">Comingled non-recyclable and putrescible waste continues to be transported to and disposed at the Zeehan landfill operated by the West Coast Council.</p> <div data-bbox="1249 896 1812 1324" data-label="Image"> </div> <p data-bbox="1016 1342 2045 1366">Photo No. 28 - Recyclable steel bulk skips for subsequent off-site removal by Recycal (16th December 2020)</p> |

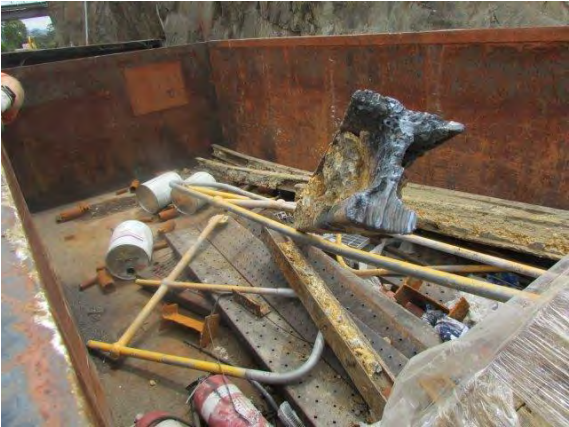
| Environmental Protection Notice Schedule & Conditions | Status | Supporting Evidence/Comments/Photographs |
|---|---|--|
| | | <p>External contractor, Recycal removes segregated recyclable steel from temporary storage locations for off-site recycling.</p> <p>Photo No. 29 – Contents of recyclable steel bulk skips (16th December 2020)</p> <p>MMG Rosebery's off-site light vehicle maintenance contractor continues to be responsible for servicing MMG vehicles and for the removal and management of used light vehicle tyres generated under this contract.</p> |

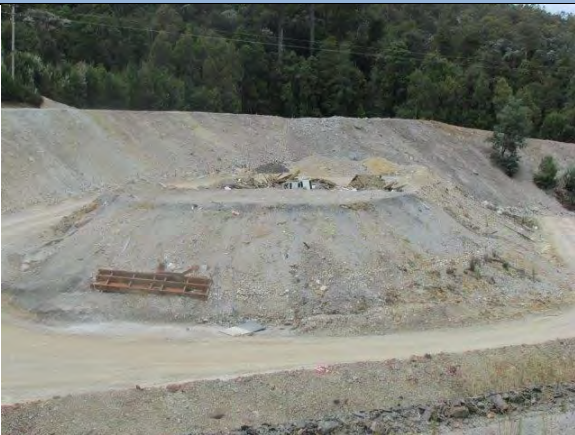
| Environmental Protection Notice Schedule & Conditions | Status | Supporting Evidence/Comments/Photographs |
|---|---|---|
| | | <p>Photo No. 31 – MMG Rosebery on-site landfill (16th December 2020)</p> <p>1.4 De Bruyns are responsible for transporting hydrocarbon containers and coolants to a Level 2 secure landfill in Port Latta. Waste oil is forwarded to De Bruyns in Wivenhoe and Tasoil then transport to a lime furnace. Oil contaminated rags and filters are transported to Port Latta.</p> <p>De Bruyns forward a monthly email to the MMG Rosebery warehouse which is received by the SHEC Department (i.e. defining the quantity of waste transported to Dulverton or Port Latta). This information is provided in an email and MMG Rosebery SHEC update and manage the spreadsheet.</p> <p>As defined in previous EPN audit reports, no regulated waste tracking system has been established within Tasmania to date (i.e. for the tracking of hazardous/ regulated waste). The majority of Tasmania's hazardous waste continues to be transported to Victoria for treatment or disposal within an authorised secure landfill.</p> |

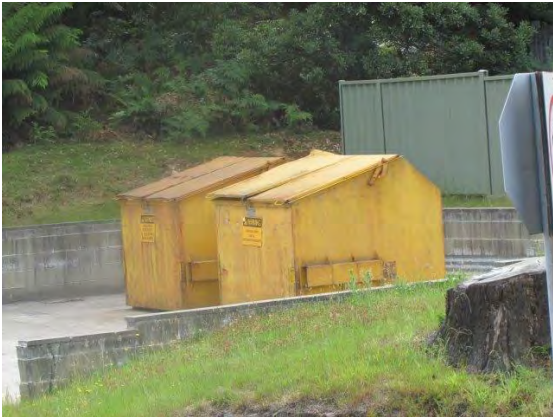
| Environmental Protection Notice Schedule & Conditions | Status | Supporting Evidence/Comments/Photographs |
|---|---|--|
| <p>Waste Management Condition WM3 – Waste Management System</p> <p>Putrescible waste must be disposed of at a site that is authorised to receive that waste.</p> | <p>Compliant</p> | <p>Bulk skips of putrescible/domestic waste are located on-site in the front carpark and within the mill.</p> <p>Photo No. 32 - Putrescible/domestic waste bins in the front carpark (16th December 2020)</p> |

| Environmental Protection Notice Schedule & Conditions | Status | Supporting Evidence/Comments/Photographs |
|---|---|---|
| | | These bulk skips continue to be owned by both West Coast Council and MMG Rosebery. These are collected by MDG/West Coast Council and the waste transported to the licenced municipal landfill located at Zeehan. |
