Environmental Management Plan Review 2016-2021

MMG Rosebery

November 2021

Includes 2020-21 Annual Monitoring Review and Management Report and 5-yearly Monitoring System Reviews

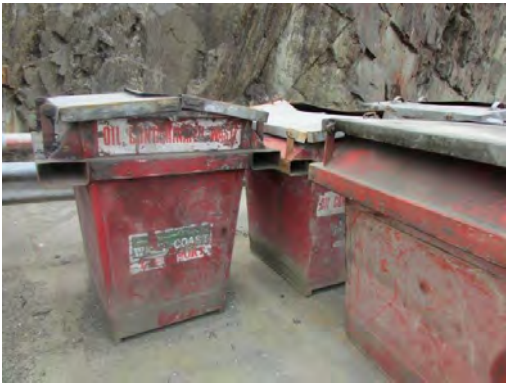
| Environmental Protection Notice Schedule & Conditions | Status | Supporting Evidence/Comments/Photographs |
|---|---|--|
| | | <p>was issued as a result of the completion of this survey (i.e. only the information that was supplied by the contractors and retained by MMG Rosebery).</p> <p>Records of waste contractor licences/certificates continue to be stated to be retained on the MMG Library.</p> <p><u>Controlled Waste Transporters</u></p> <p>The key controlled waste contractors and the regulated waste products authorised to be removed and transported include:</p> <ul style="list-style-type: none"> • De Bruyn's (hydrocarbon/liquid/coolant waste to a Level 2 secure landfill in Port Latta); • De Bruyn's for waste oil that is forwarded to De Bruyns facility in Wivenhoe and Tasoil, which is consumed in a lime furnace; • De Bruyn's for oil contaminated rags and filters to Port Latta; • One-stop (One-Steel) (recycling of batteries, steel); • MDG (lead/zinc contaminated waste to Bobadil); • West Coast Council (general waste to the Zeehan landfill); • JJ Richards (hazardous waste); and • External specialist contractor (asbestos waste to Dulverton, Zeehan or near Burnie) which was last removed in 2014. <div data-bbox="1279 943 1783 1326"> </div> <p>Photo No. 33 – Oil Contaminated Waste Bins at the Waste Laydown Yard (16th December 2020)</p> |

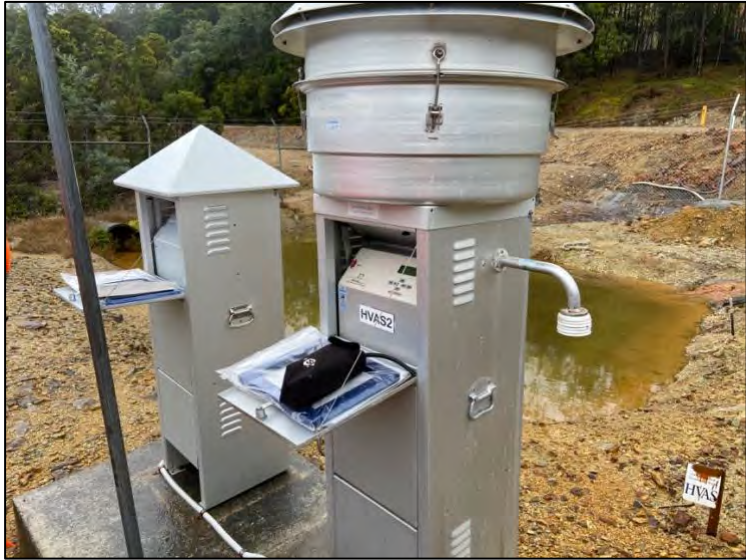
| EPN 7153/3 Condition | C, NC, OI | Audit Findings |
|---|---|---|
| | OI | <p>HVAS samplers at Site AD3</p> <p>Updated work instructions titled <i>HVAS Calibration</i> and <i>HVAS</i> have been developed however at the time of the audit were not issued or under document control. An opportunity exists to finalise and issue these documents in order that they can replace the existing document as intended.</p> |

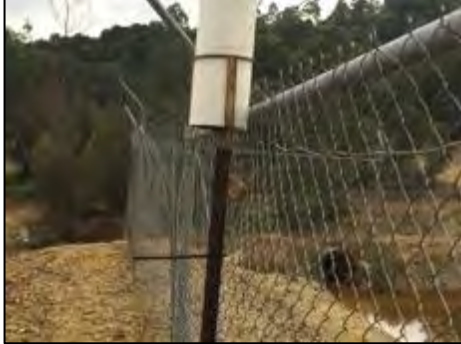
| EPN 7153/3 Condition | C, NC, OI | Audit Findings |
|---|---|---|
| | | <p>Site AD3 cable tied to fence and supported by rock wedged behind in an attempt to maintain the funnel in the correct orientation. Any movement of the fence however resulted in the gauge shaking violently.</p> |

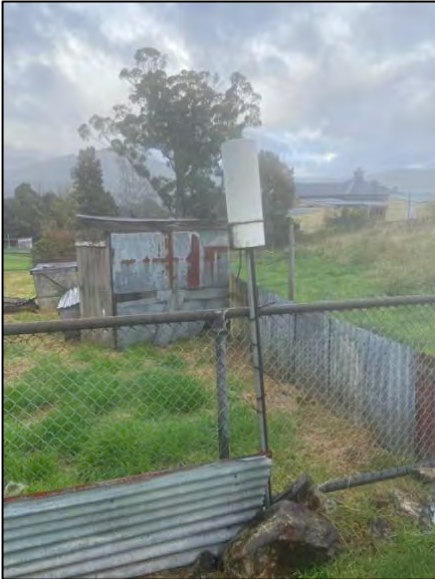
| EPN 7153/3 Condition | C, NC, OI | Audit Findings |
|--|--|---|
| | | <p data-bbox="1330 863 1442 887">Site AD 21</p> |

| EPN 7153/3 Condition | C, NC, OI | Audit Findings |
|--|--|---|
| <p data-bbox="159 1086 181 1110">4</p> <p data-bbox="159 1150 1167 1238">Measurements at the 'additional sites' (BG3, AD11, AD21, AD22, AD23 and AD25) are to continue until such time as an annual pattern can be established and a full 12-month dataset is compiled.</p> <p data-bbox="159 1278 1167 1334">This data is to be analysed in a report presented to the Director, containing recommendations and a request for approval to remove specific 'additional sites' from</p> | <p data-bbox="1240 1158 1263 1182">C</p> <p data-bbox="1240 1318 1263 1342">OI</p> | <p data-bbox="1330 1158 2078 1182">Monitoring at the additional sites specified in EPN 7153/3 is ongoing.</p> <p data-bbox="1330 1286 2078 1342">Given these additional sites have been monitored from at least 2012 it is recommended that an application is made to the EPA Director to</p> |
