Annual Monitoring Review and Management Report 2021-22

MMG Rosebery

30th September 2022

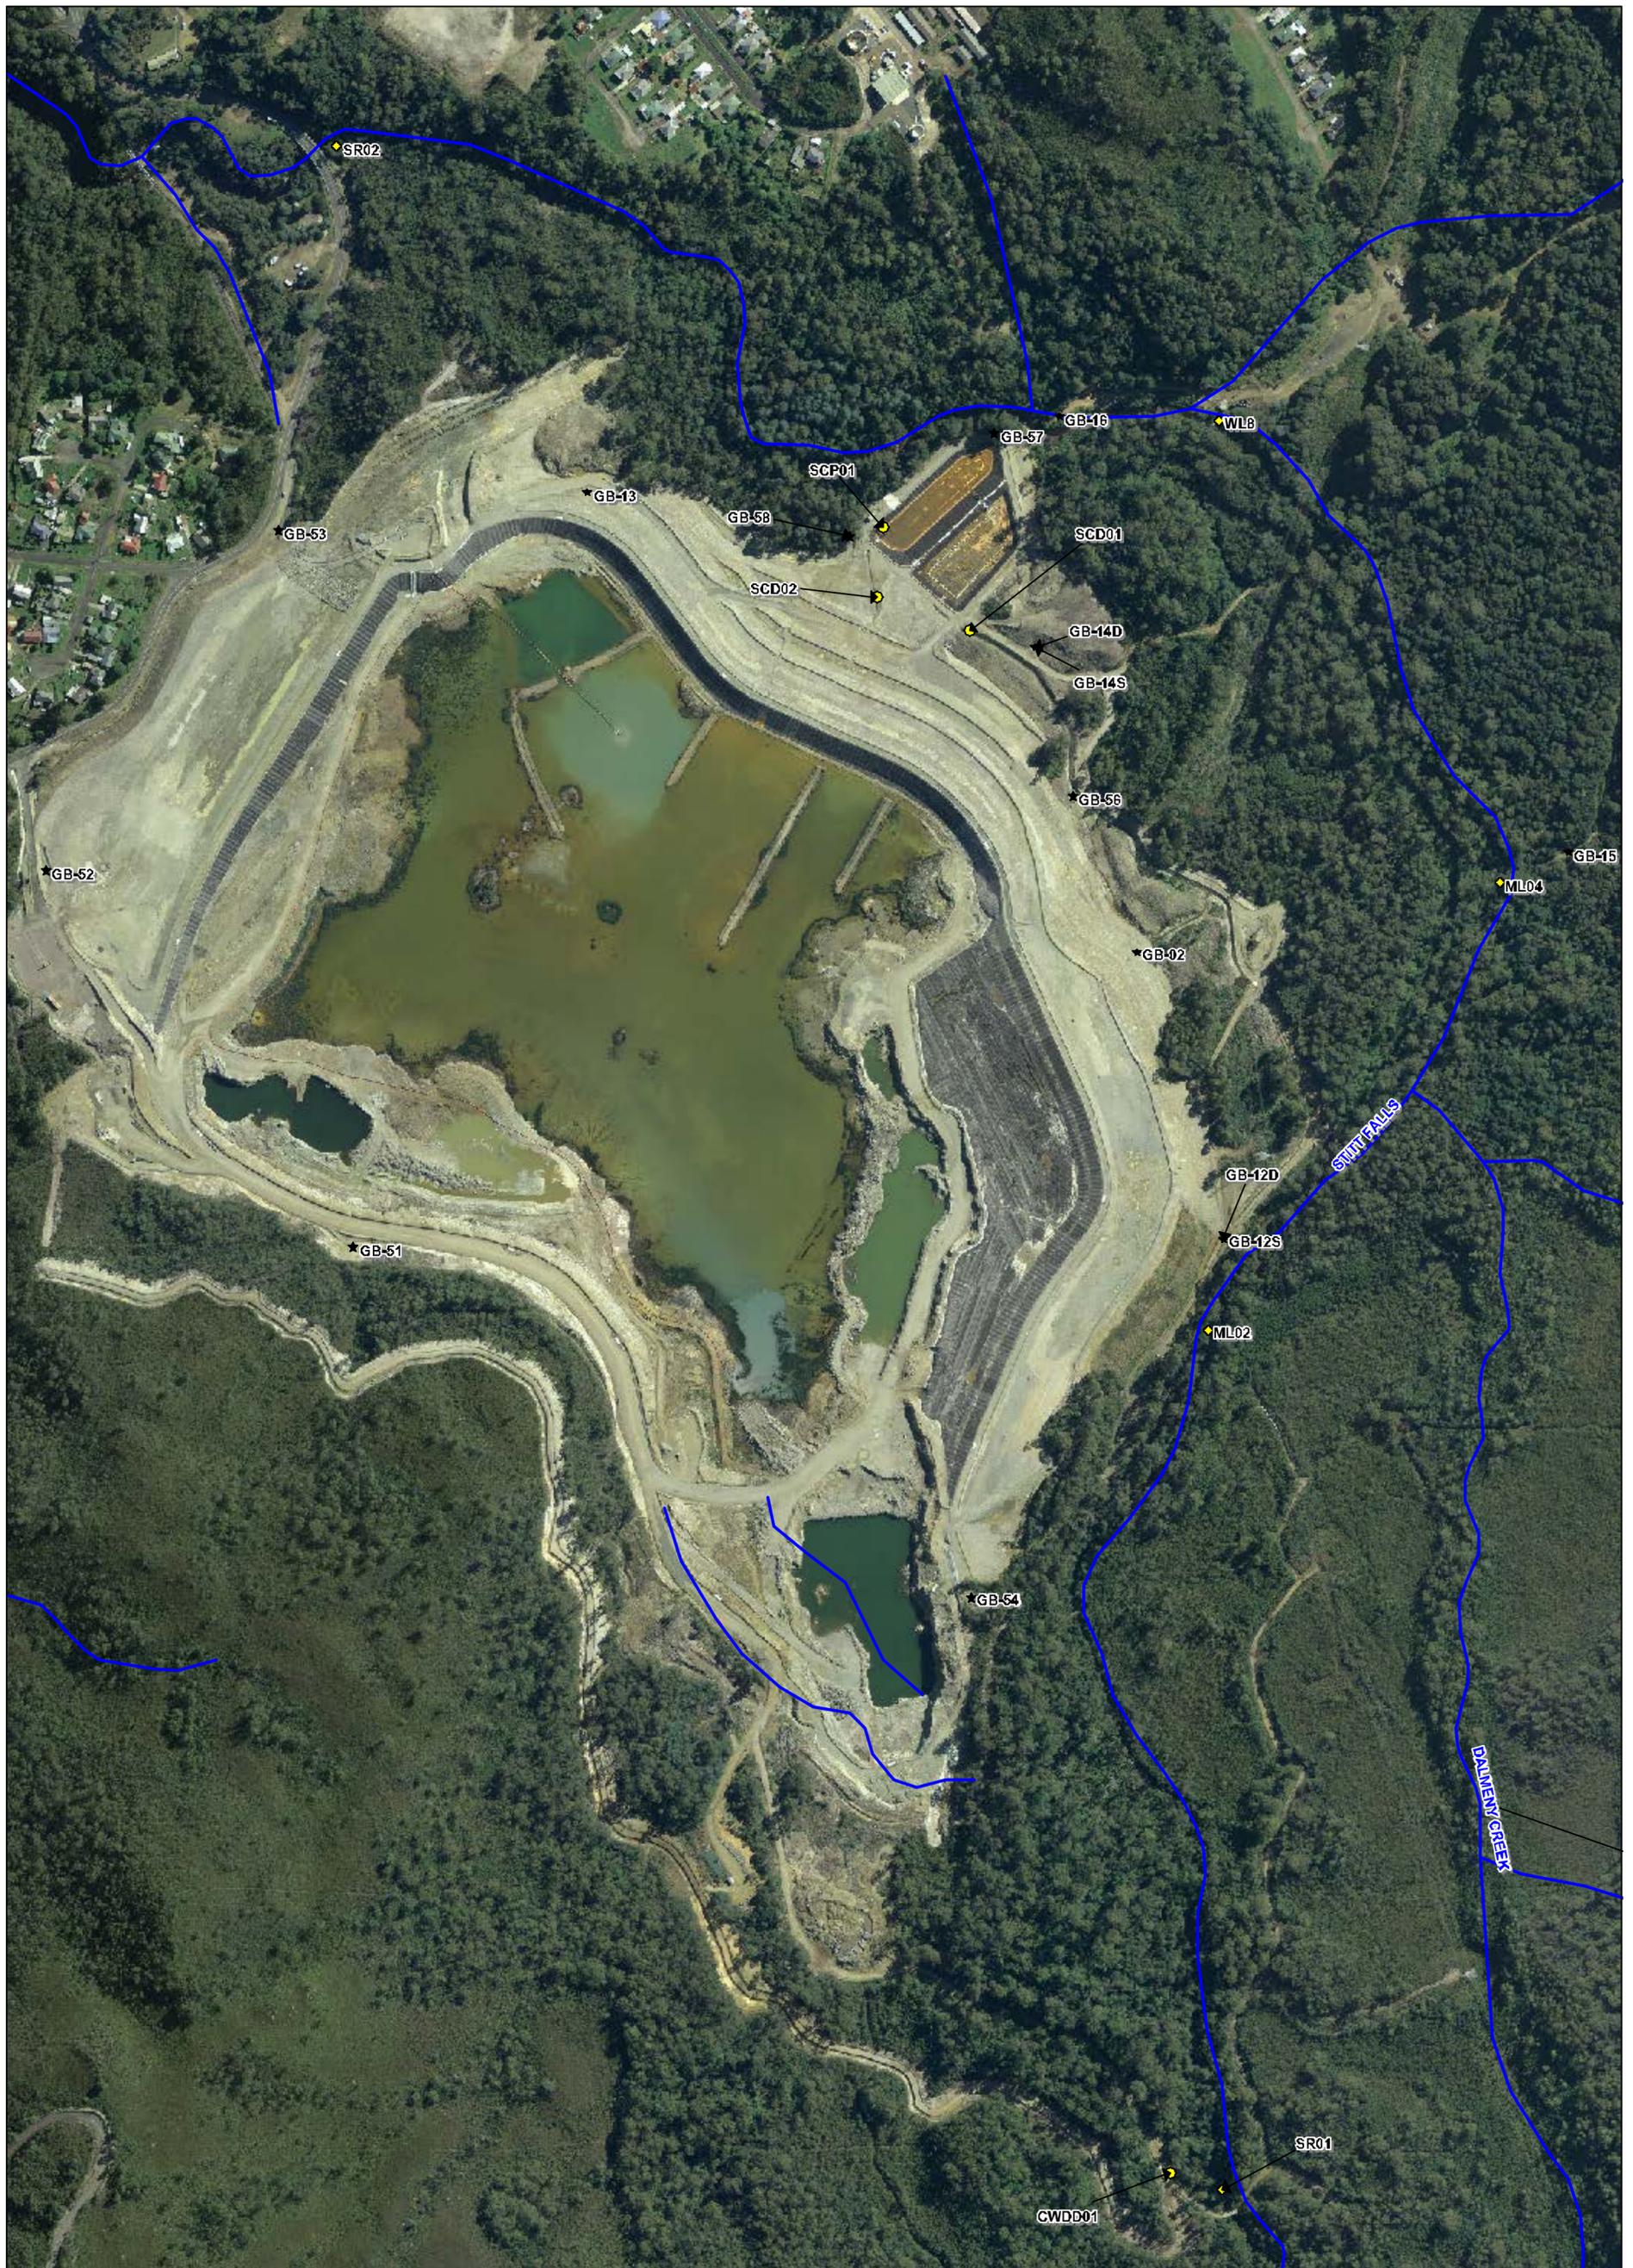
Figure A.3

Hercules and Mount
Read Water Monitoring
Locations

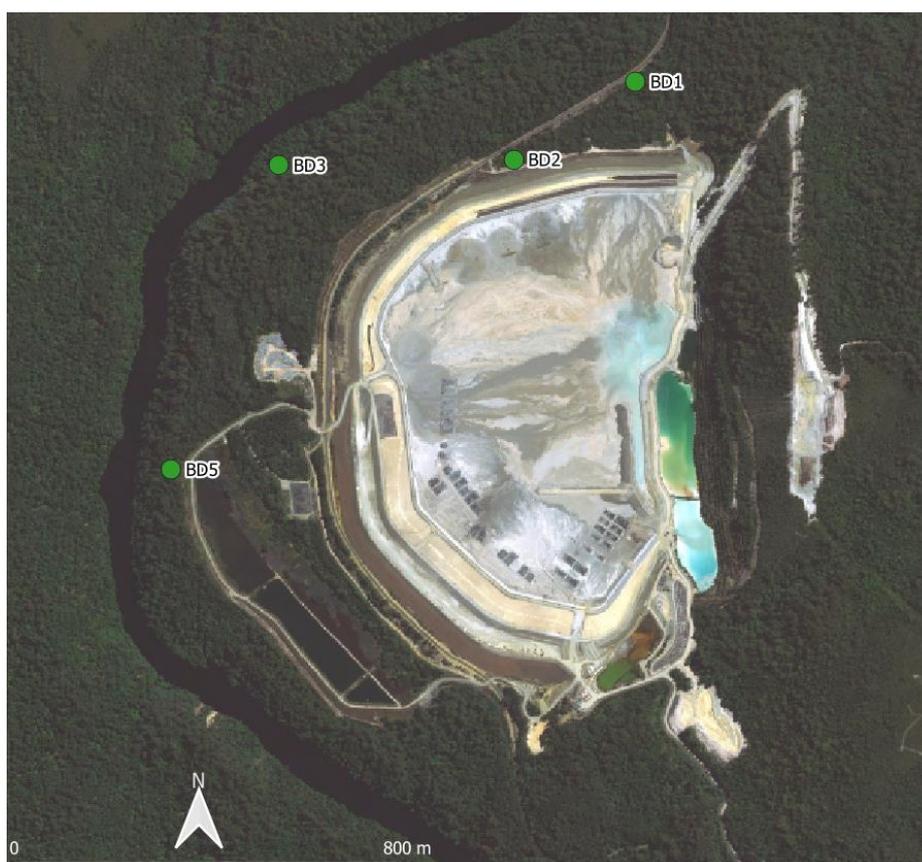
Figure 4-1. Seepage monitoring locations at Bobadil TSF.

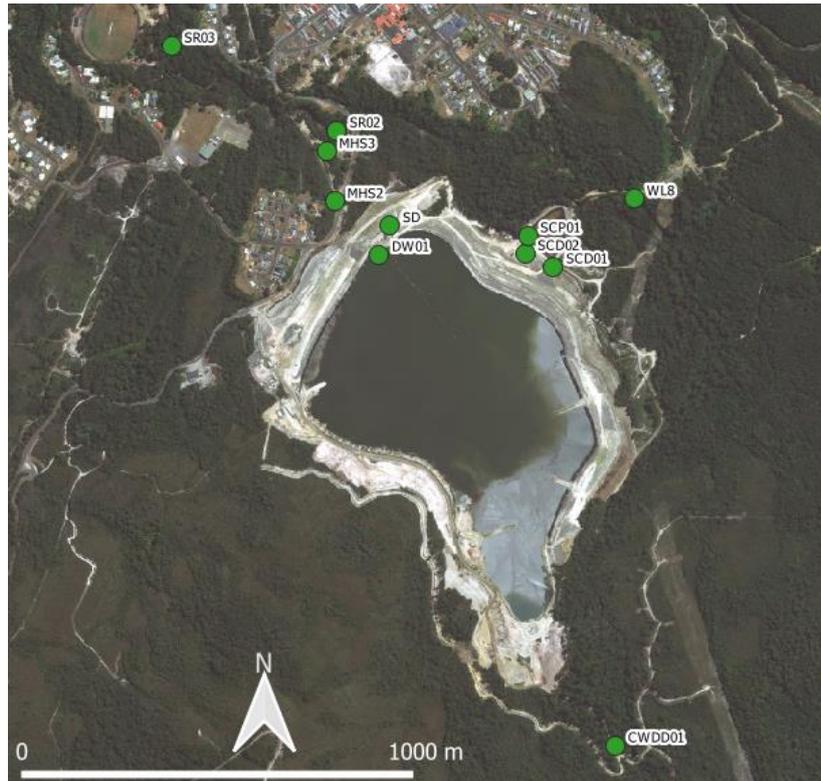
Figure 6-1. Tailings decant and surface water monitoring associated with the 2/5 TSF. Monitoring site U/S Pie is located downstream of SR03, off of the aerial photo.

During the 2021-2022 monitoring year there was one unintentional discharge of tailings from the 2/5 TSF as described in Section 1.2. There were no releases of decant water from the dam into the Stitt River. Compliance water quality monitoring is based on the sites listed in Table 6-1 and Figure 6-2, and monitoring compliance is summarised in Table 6-2.

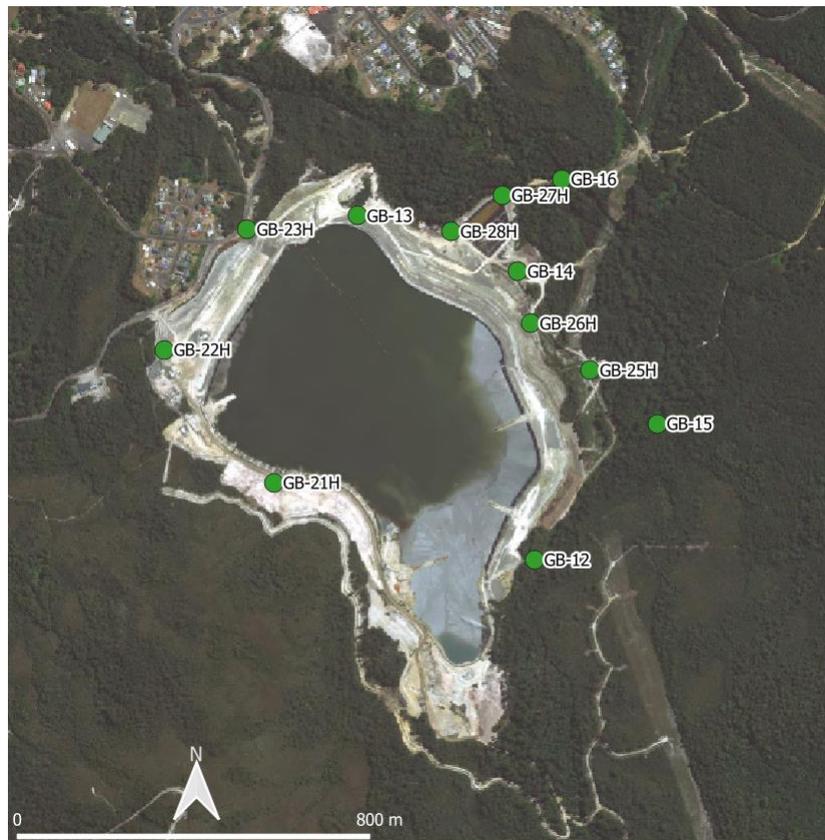
Figure 6-2. Groundwater bore monitoring locations associated with the 2/5 TSF. .

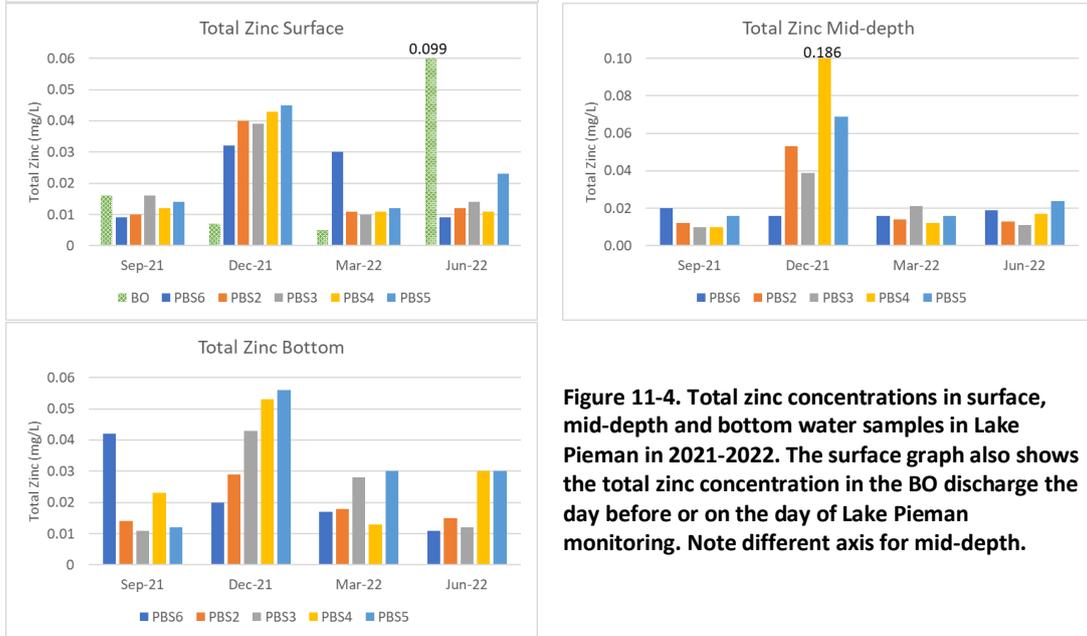
Figure 11-4. Total zinc concentrations in surface, mid-depth and bottom water samples in Lake Pieman in 2021-2022. The surface graph also shows the total zinc concentration in the BO discharge the day before or on the day of Lake Pieman monitoring. Note different axis for mid-depth.

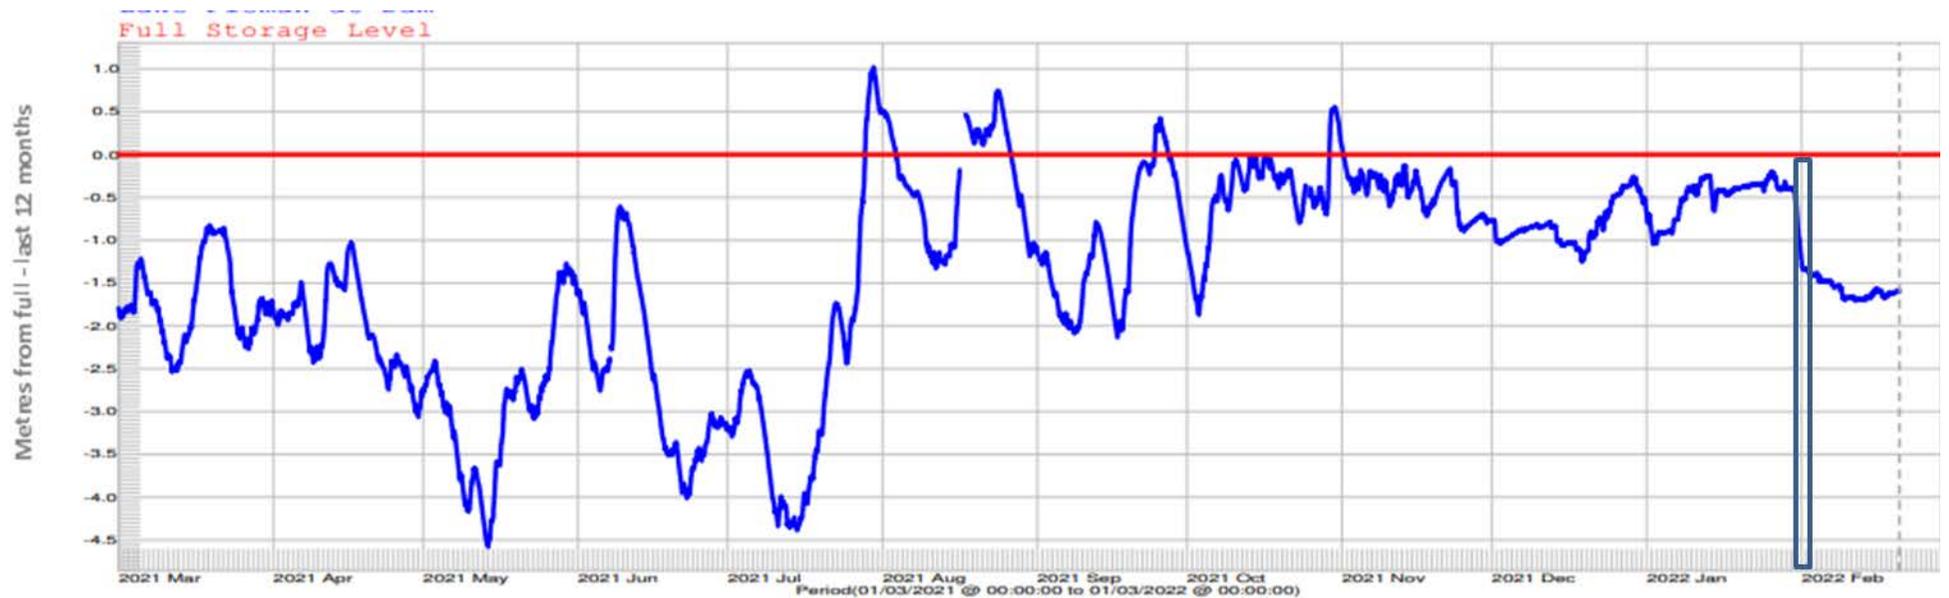
Figure 6. Lake levels of Lake Pieman from March 2021 to February 2022. Sampling date (Jan 31 – Feb 1) is shown by vertical bar. Source: Hydro Water: <https://www.hydro.com.au/water/lake-levels>.

Previous Lake Pieman sampling has been conducted in either spring or autumn seasons (see Davies et al. 2005 and subsequent reports). The inherent variability in the lake level has made it difficult to situate sampling in a period of relative lake stability, and following the most recent sampling event (October 2020) a recommendation was made to shift sampling to the summer months. Lake levels are generally more stable during the Dec – Feb period, although level fluctuation still occur. As a result, sampling in 2022 was conducted in late January/early February, with the date of sampling chosen to coincide with a period of relatively stable lake levels over the preceding 14 days (see Figure 6).

In the two weeks prior to sampling, lake levels were relatively stable, fluctuating between 0.3 - 0.6 m below spill level. Lake levels dropped abruptly by ca. 80 cm overnight on first day of sampling (31 January) and were then stable on the second day of sampling (1 February) (Figure 6).

Sampling in 2022 was shifted to summer (Jan – Feb) in an attempt to minimise the effects of fluctuating lake level, with levels in Lake Pieman generally less variable in the summer months. Sampling was timed to follow a two-week period of relative stability in lake levels (levels fluctuating within a range of +/- 30 cm; see Figure 6).

Over the two weeks prior to the first day of sampling (31 January) lake levels had been relatively stable but dropped ca. 80 cm on the second day of sampling on 1 February (Figure 6).

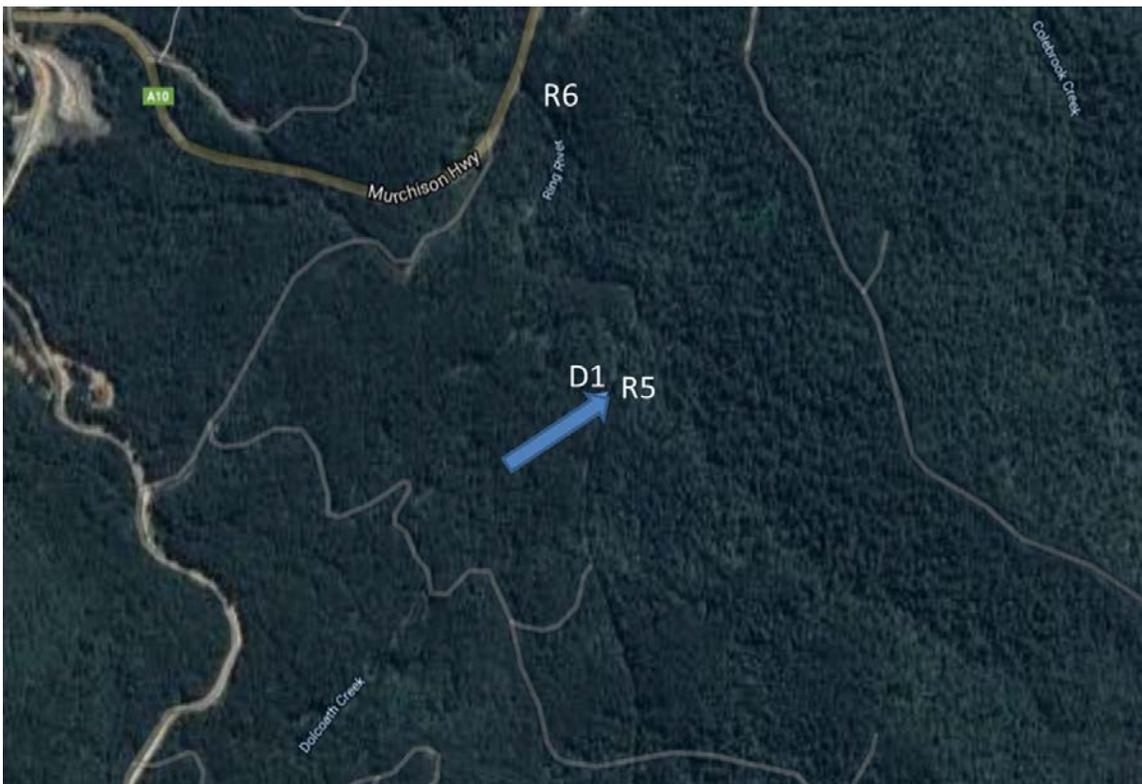
Figure 2b. Map of study sites in the lower Ring River catchment. Blue arrow shows point of confluence of Dolcoath Creek and the Ring River

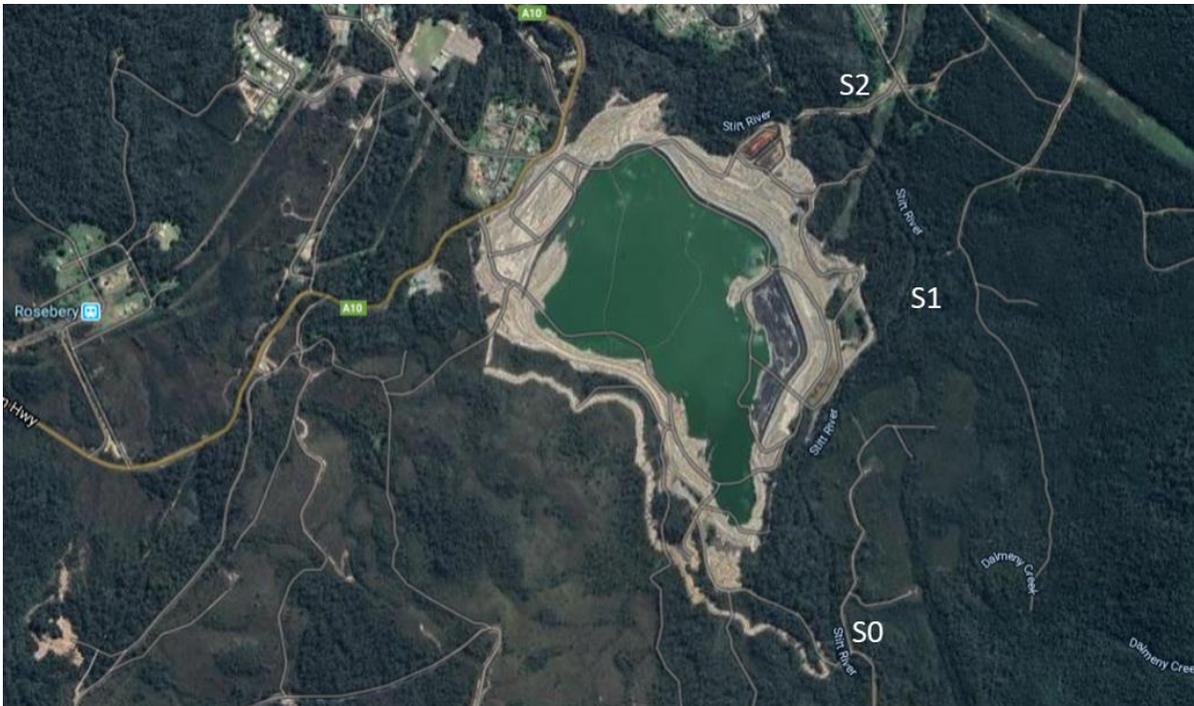
Figure 3a. Map of study sites in the upper Stitt River catchment.
